# Pitted Batch O Camshaft Results

SOUTHWEST RESEARCH INSTITUTE®

FUELS & LUBRICANTS RESEARCH

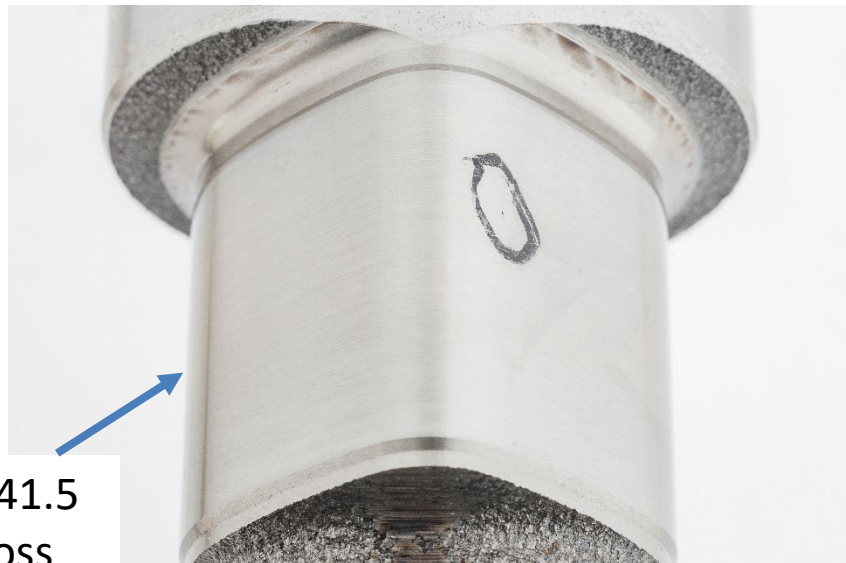
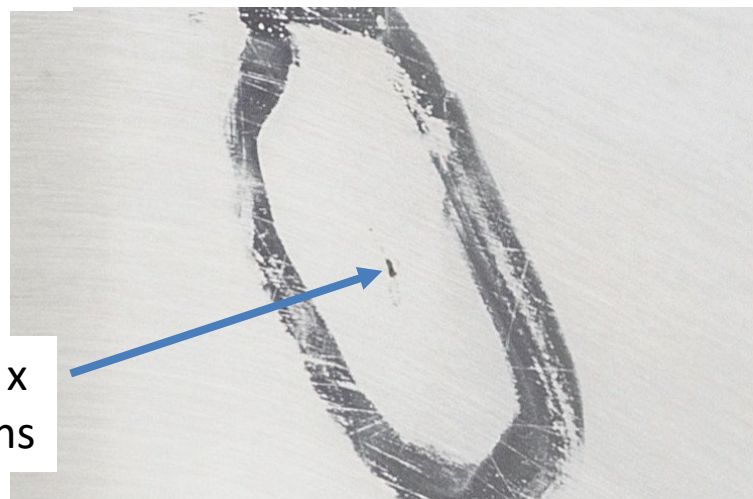
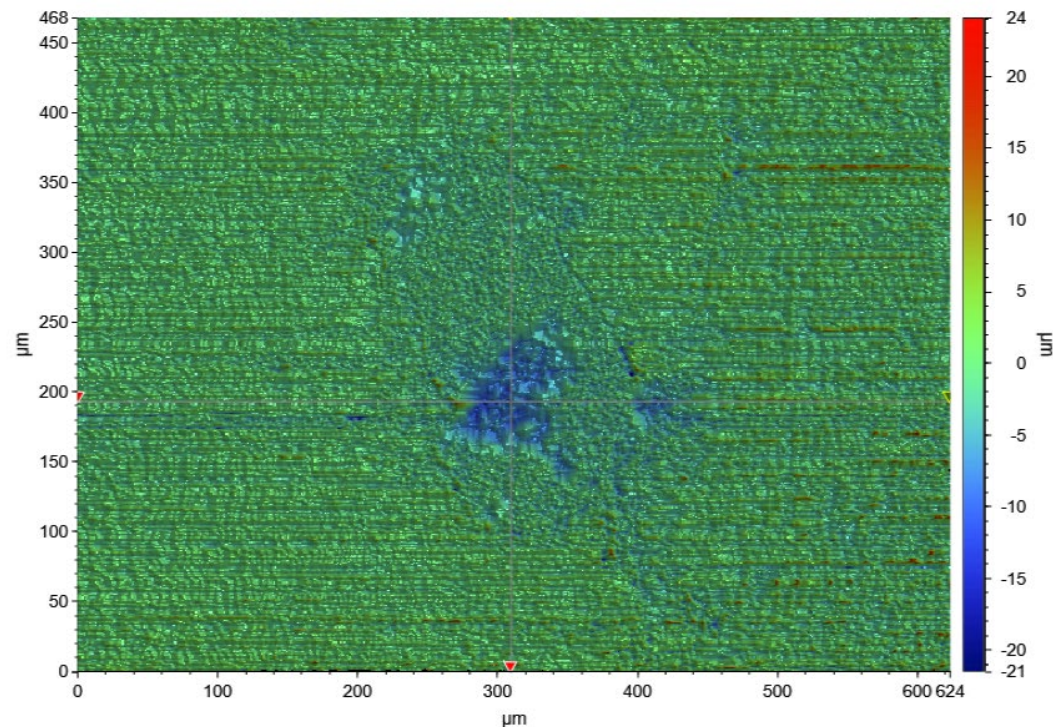
Lobe 12 of CMIR-202553

# What is a pit

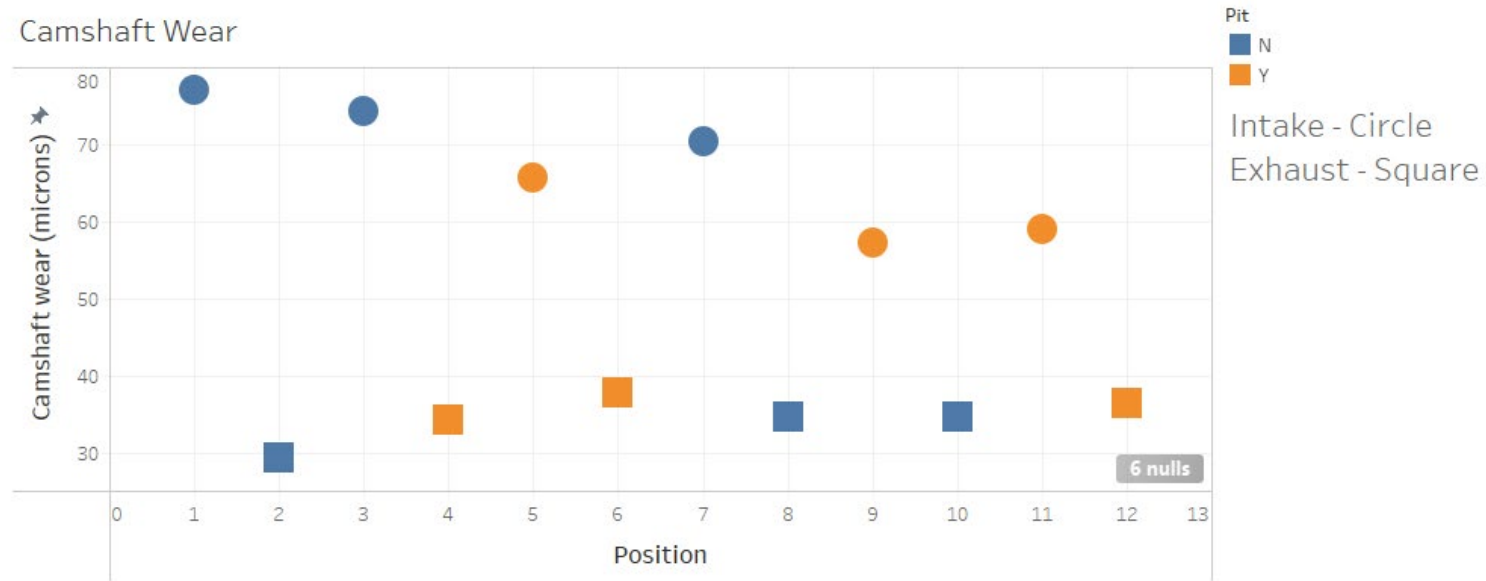
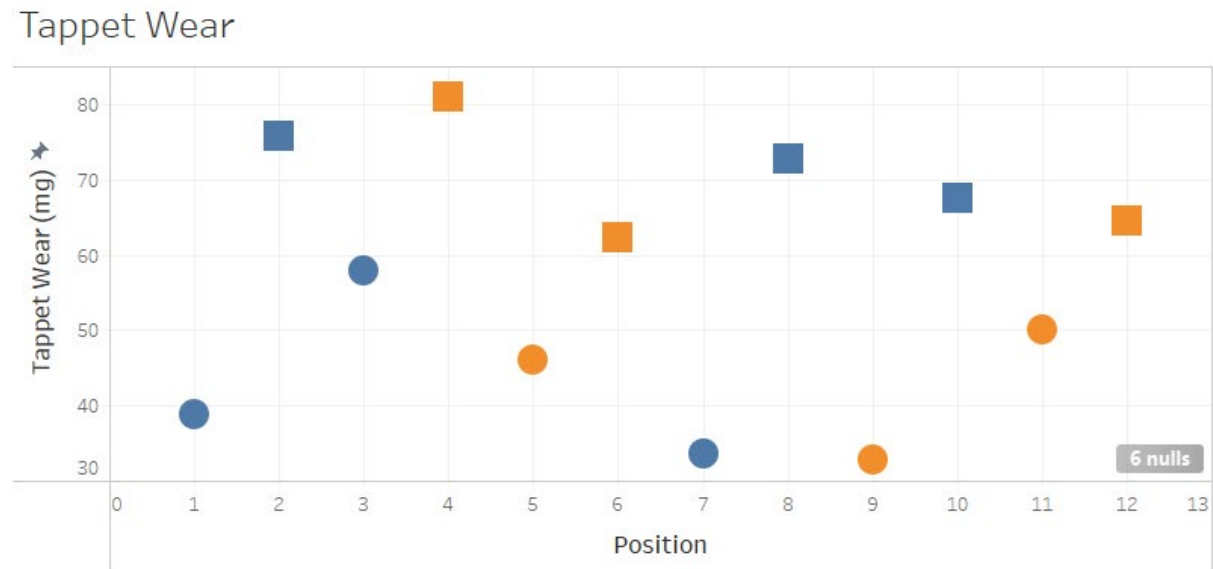
- Individual lobe averages
  - No corrections/transforms
- No evidence of increased wear on pitted cam lobes
- No evidence of increased wear on tappets with pitted cam lobes

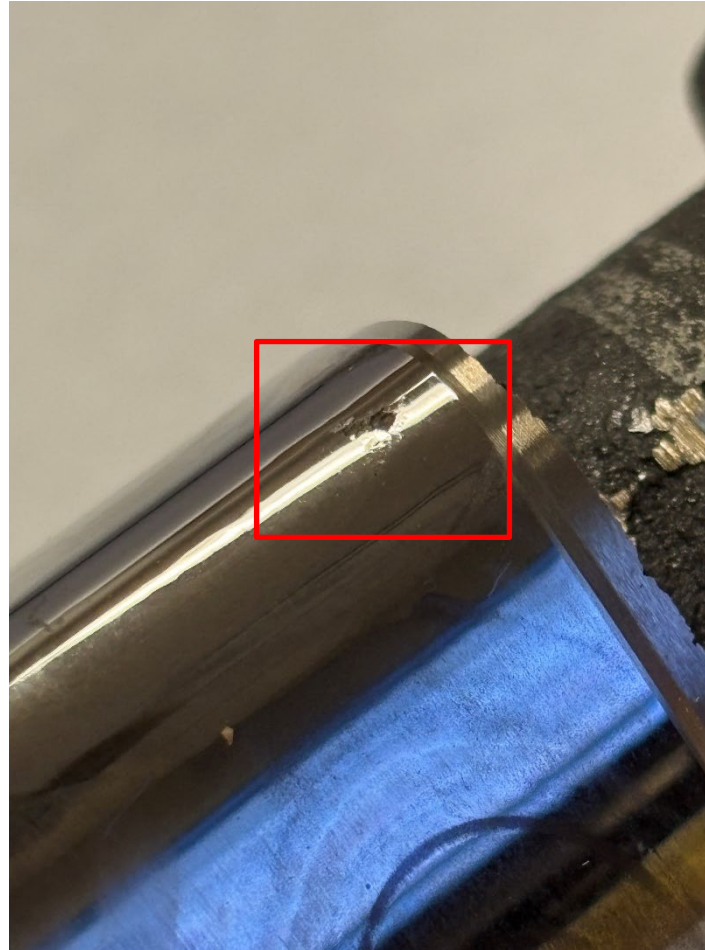
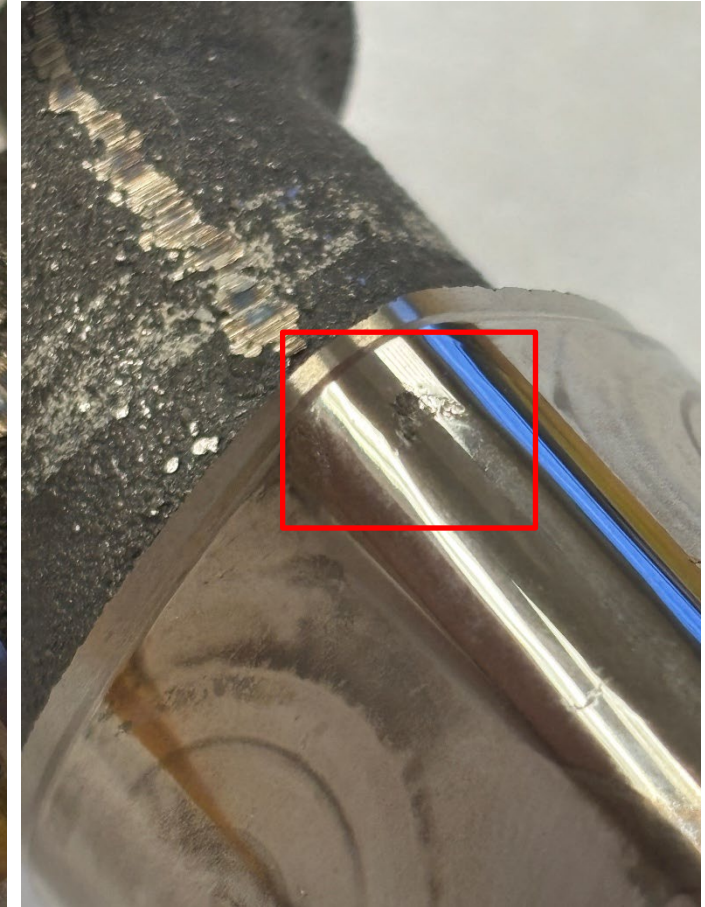
Lobe 2 of CMIR-195527  
(non-pitted)

- Flaked off material is a common problem in previous, and current, batches
- Only 1 of the pitted lobes had any flaking
  - Not located at pit site

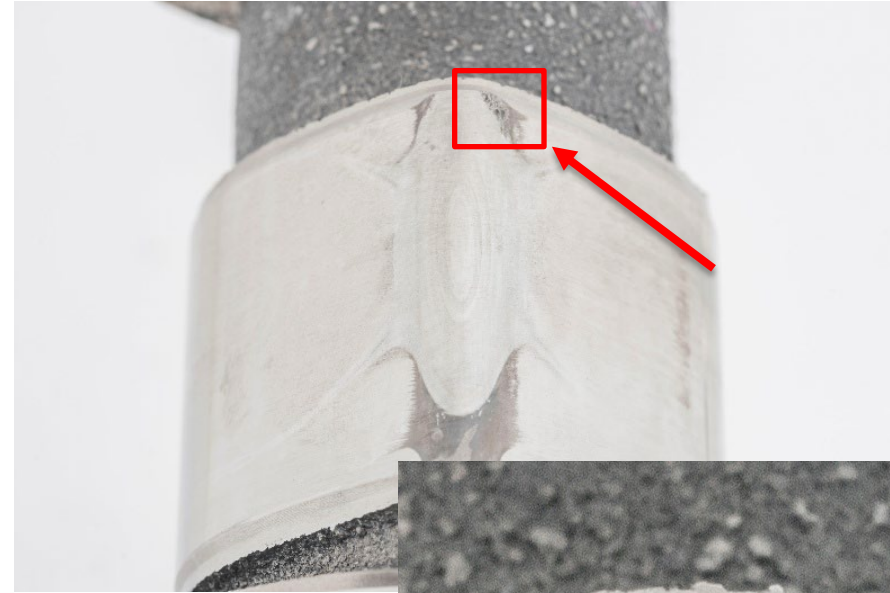
Lobe 11 of CMIR-195527  
(non-pitted)

- Following slides show camshaft lobes with visible flakes called out by red arrows
- All prior tests are EOT only, pitted cam run has both BOT and EOT

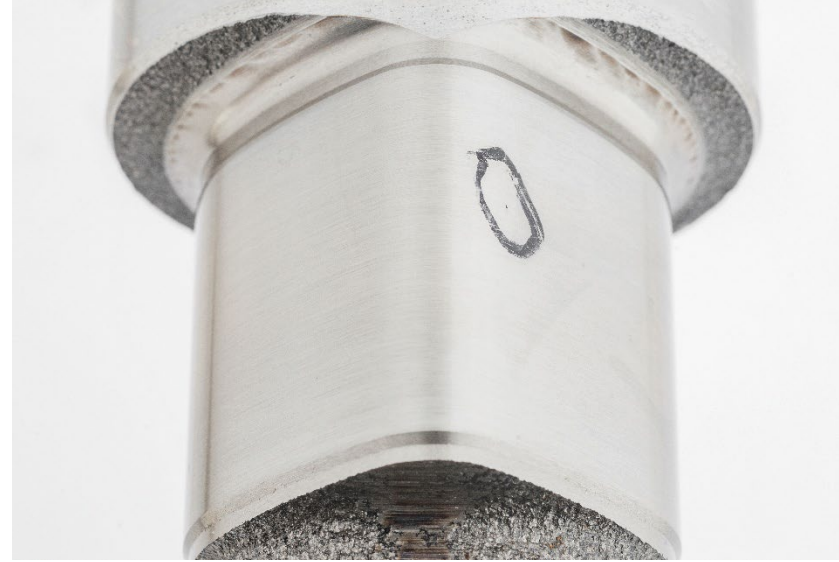
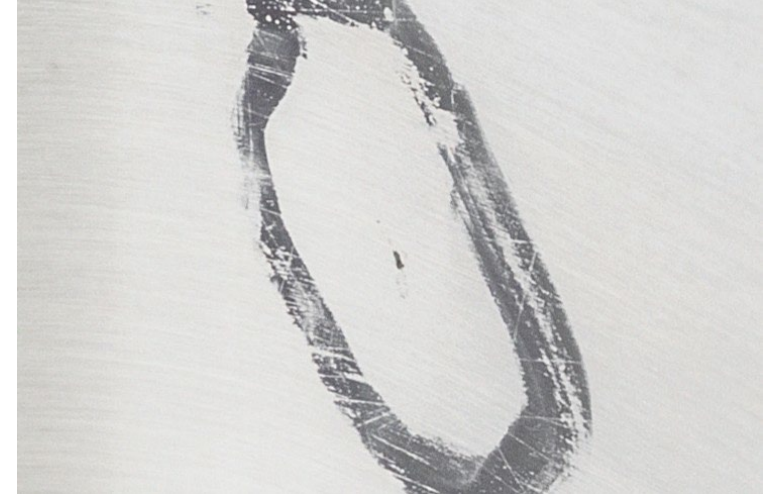
- A pitted cam produced what would be a passing reference
- Pitted camshaft lobes did not show a shift in severity vs non-pitted lobes
- Tappet wear was consistent across pitted vs non-pitted lobes

- The panel directs TEI to allow the distribution, for labs willing to accept them, of kits with camshafts containing up to one intake lobe and one exhaust lobe with a visible “pit” as a rolling change. Test reports are to include identification of pitted lobes noted in the comment section.

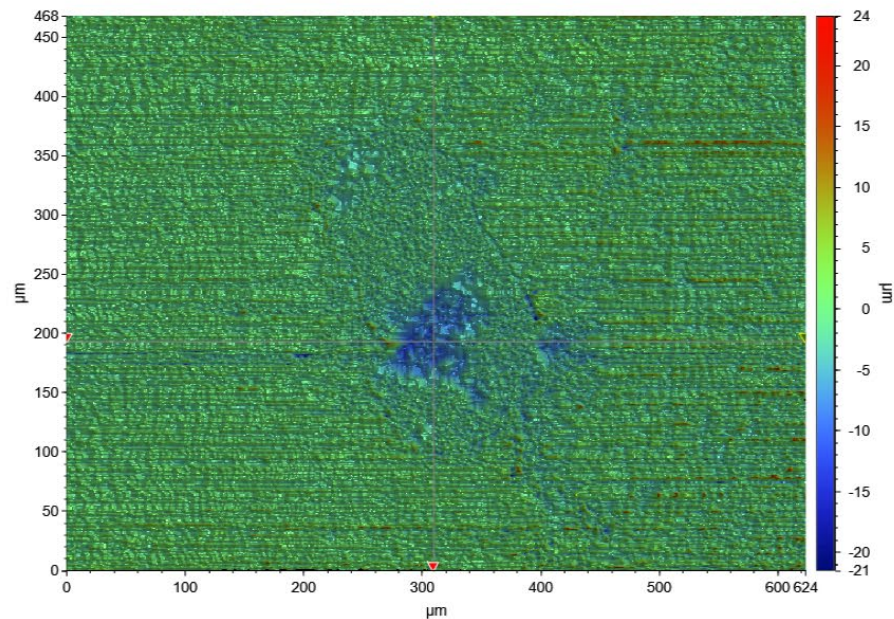
# Bruker Images – Pit on Lobe I2

X Profile:  $\Delta X=622.6476 \mu\text{m}$ ;  $\Delta Z=4.4301 \mu\text{m}$

Y Profile:  $\Delta X=466.7421 \mu\text{m}$ ;  $\Delta Z=0.0342 \mu\text{m}$

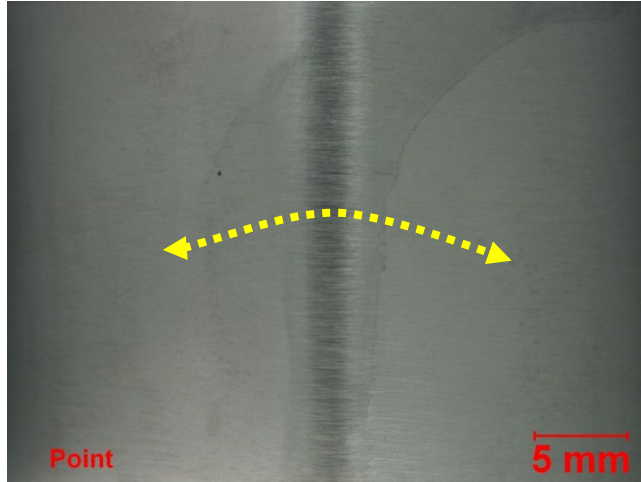
Stereoscope image of Lobe Tip

- The lobe tip was examined by scanning electron microscopy (SEM)
- SEM images demonstrated typical wear features
- Linear scratches were present and oriented parallel to the yellow arrow over the stereoscope image
- Discrete pits over the surface exhibited obvious scratches as material was removed and dragged over the surface
- Discrete pits exhibited maximum opening between 5-7  $\mu\text{m}$  (0.0002"); maximum elongation was measured in the range of 10-20  $\mu\text{m}$  (0.0004-0.0008")

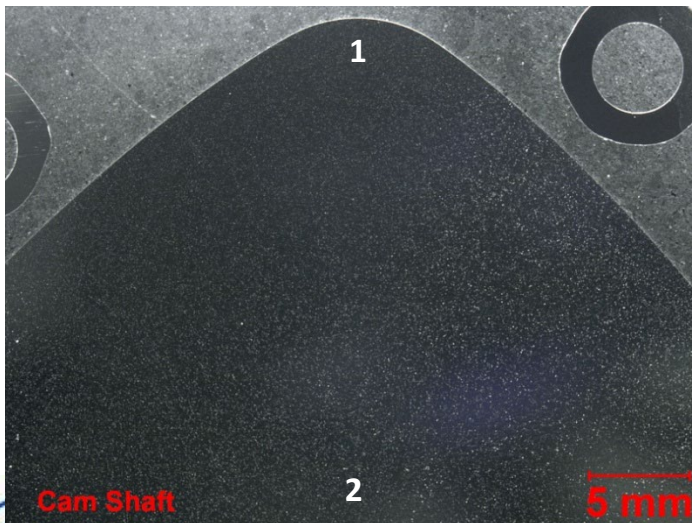
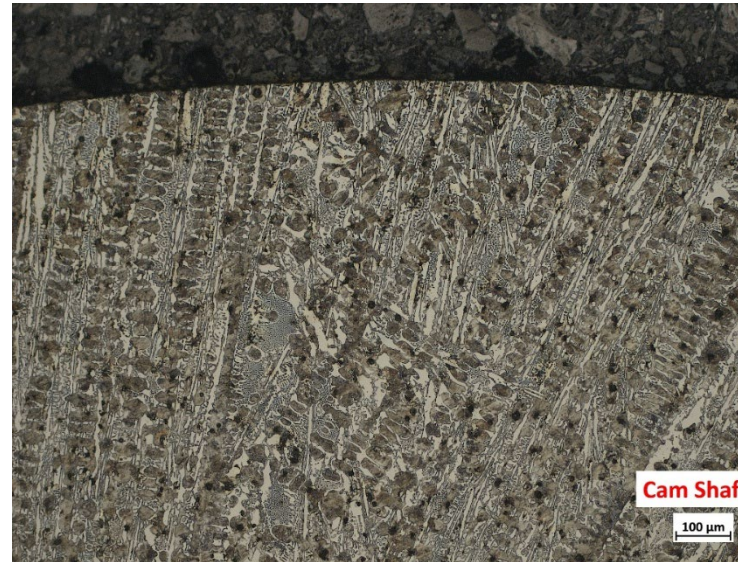
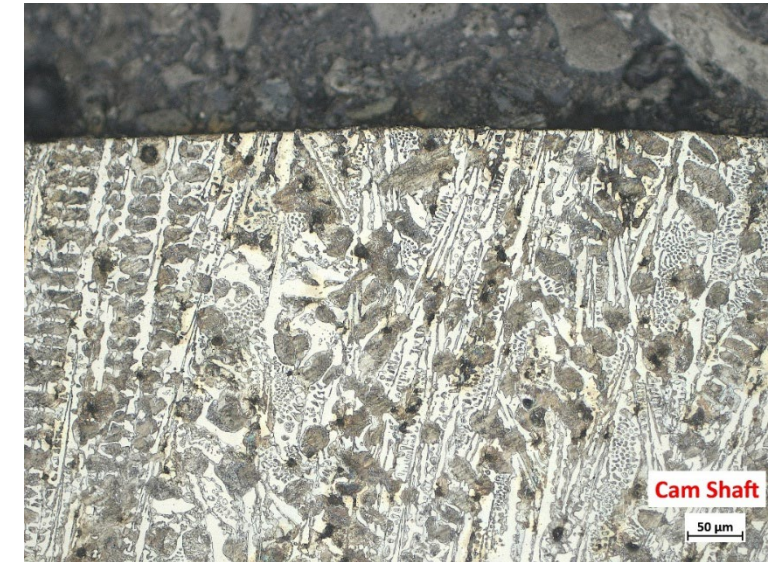
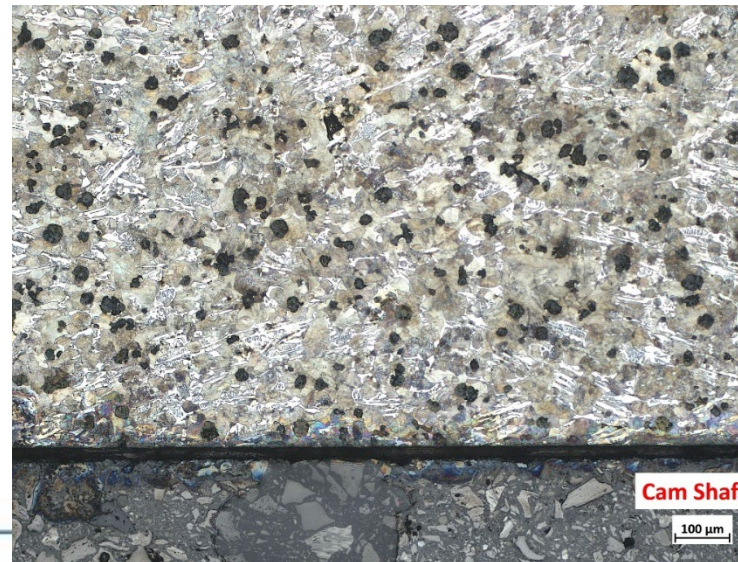
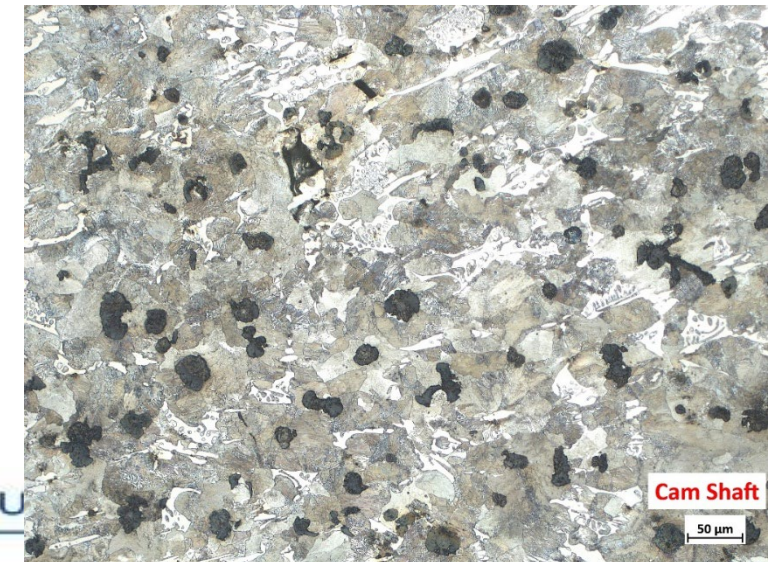
Stereoscope image of the polished cross-section

- The etched micrographs demonstrated a chilled cast iron microstructure
- Chilled cast iron constituents consisted of pearlite (dark), and interdendritic carbide (white)
