Committee D02 on PETROLEUM PRODUCTS AND LUBRICANTS

ASTM D02.B0.03 L-37 Surveillance Panel

Report of Dana Facility Visits by
L-37 Hardware Task Force
November 29, 2005 Ft. Wayne IN Facility Visit

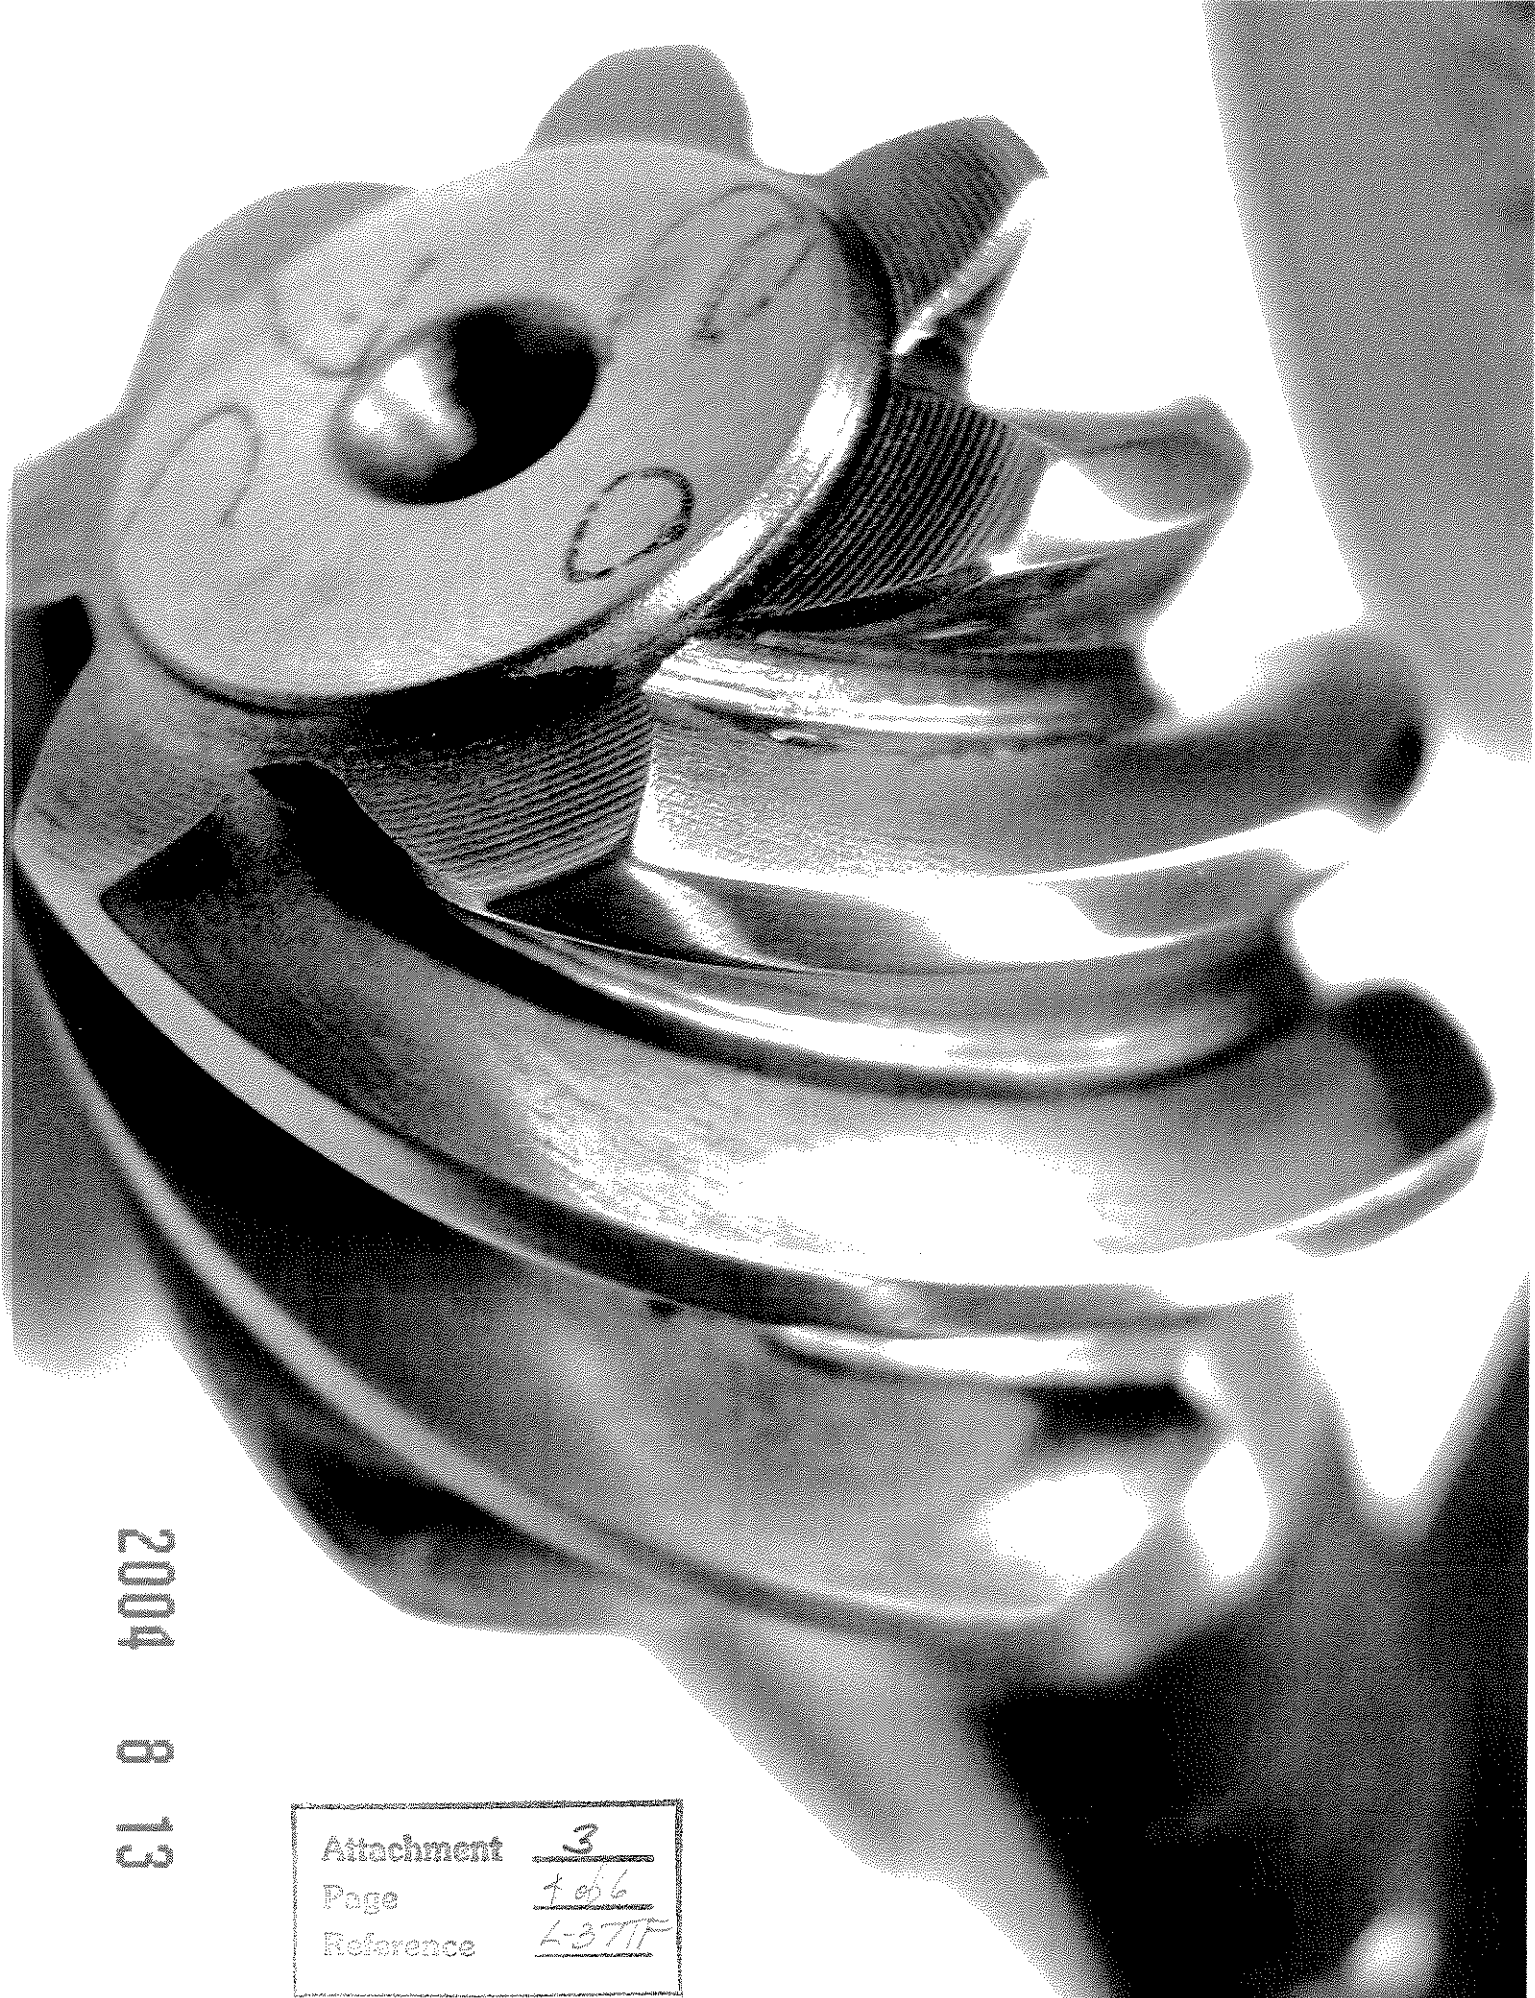
Attachment	<u>3</u>
Page	<u>346</u>
Reference	<u>L-37TF</u>

- **Attachment 3** - details a memo and photos from Mr. Okamuro for the Ft. Wayne produced 2004 non-lubrited hardware batch we desire Dana to duplicate. These are examples of acceptable/typical tooling marks found in the P4T771/V1L351 gear batch for clarification of our expected needs.

- e) Lou Pappademos in Ft Wayne sent me photos of the surface finish. The pictures are not the greatest but maybe you can tell if it appears to have sufficient tool marks for wear rating. (See attached file:

- 1) 060GA105x Lapped PCX Surface.jpg)
 - 2) 060GA105x Lapped GCX Surface.jpg)
 - 3) 060GA105x Lapped PCV Surface.jpg)
 - 4) 060GA105x Lapped GCV Surface.jpg)

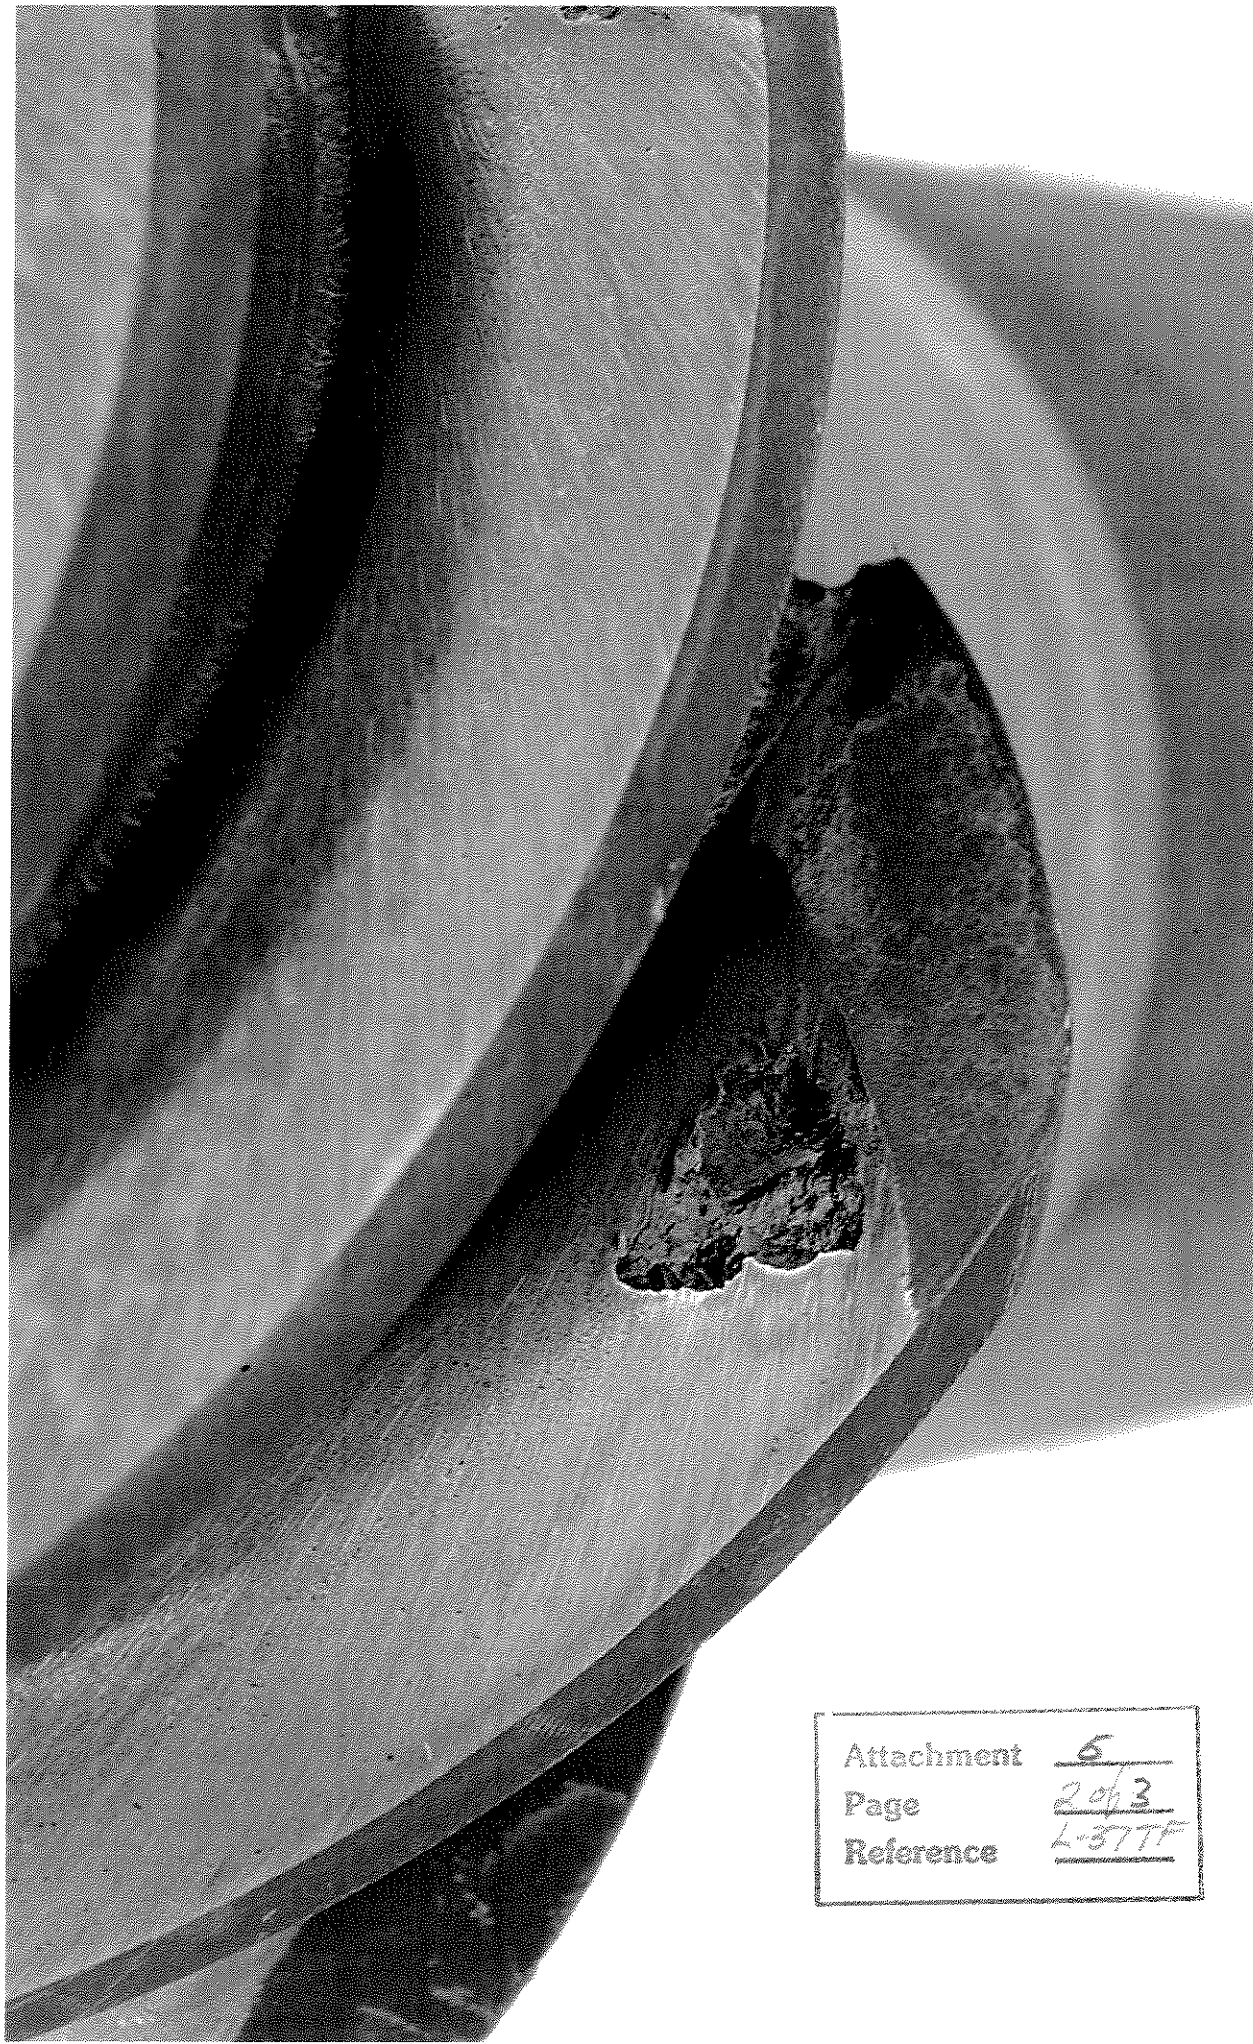
Attachment	<u>5</u>
Page	<u>1 of 3</u>
Reference	<u>L-37 TF</u>

I looked at your pictures and it is obvious that the top land damage is the result of a rework attempt to grind out handling damage. The spall at the heel is less clear. It does look like there is an excessive acute angle chamfer on the tooth (this chamfer is a normal operation). The significance of this is that the chamfer subtracts from the contact area that must carry the load, especially under high loads where the contact spreads to the heel. It is difficult for me to tell from the picture how wide the chamfer is since I have no scale comparison, but it looks relatively wide. This loss of tooth stress carrying area means that the area just in front of the chamfer must carry more load since the pattern effectively runs off the heel of the tooth where the chamfer begins. All things being equal, it is likely to spall at that spot.

This invalidated test is likely the result of improper manufacturing technique by the responsible Dana factory. Hopefully this is a fairly isolated incident.

Would you please give me a call when you get this? The pinion is from a reference test that I invalidated because I believe it to be a manufacturing defect that our technician did not catch during cleaning. I will try to teleconference in Mr. Lind if we can do it early this afternoon.
