IIIH PM Op Data Review Fourth Round of IIIH PM Tests

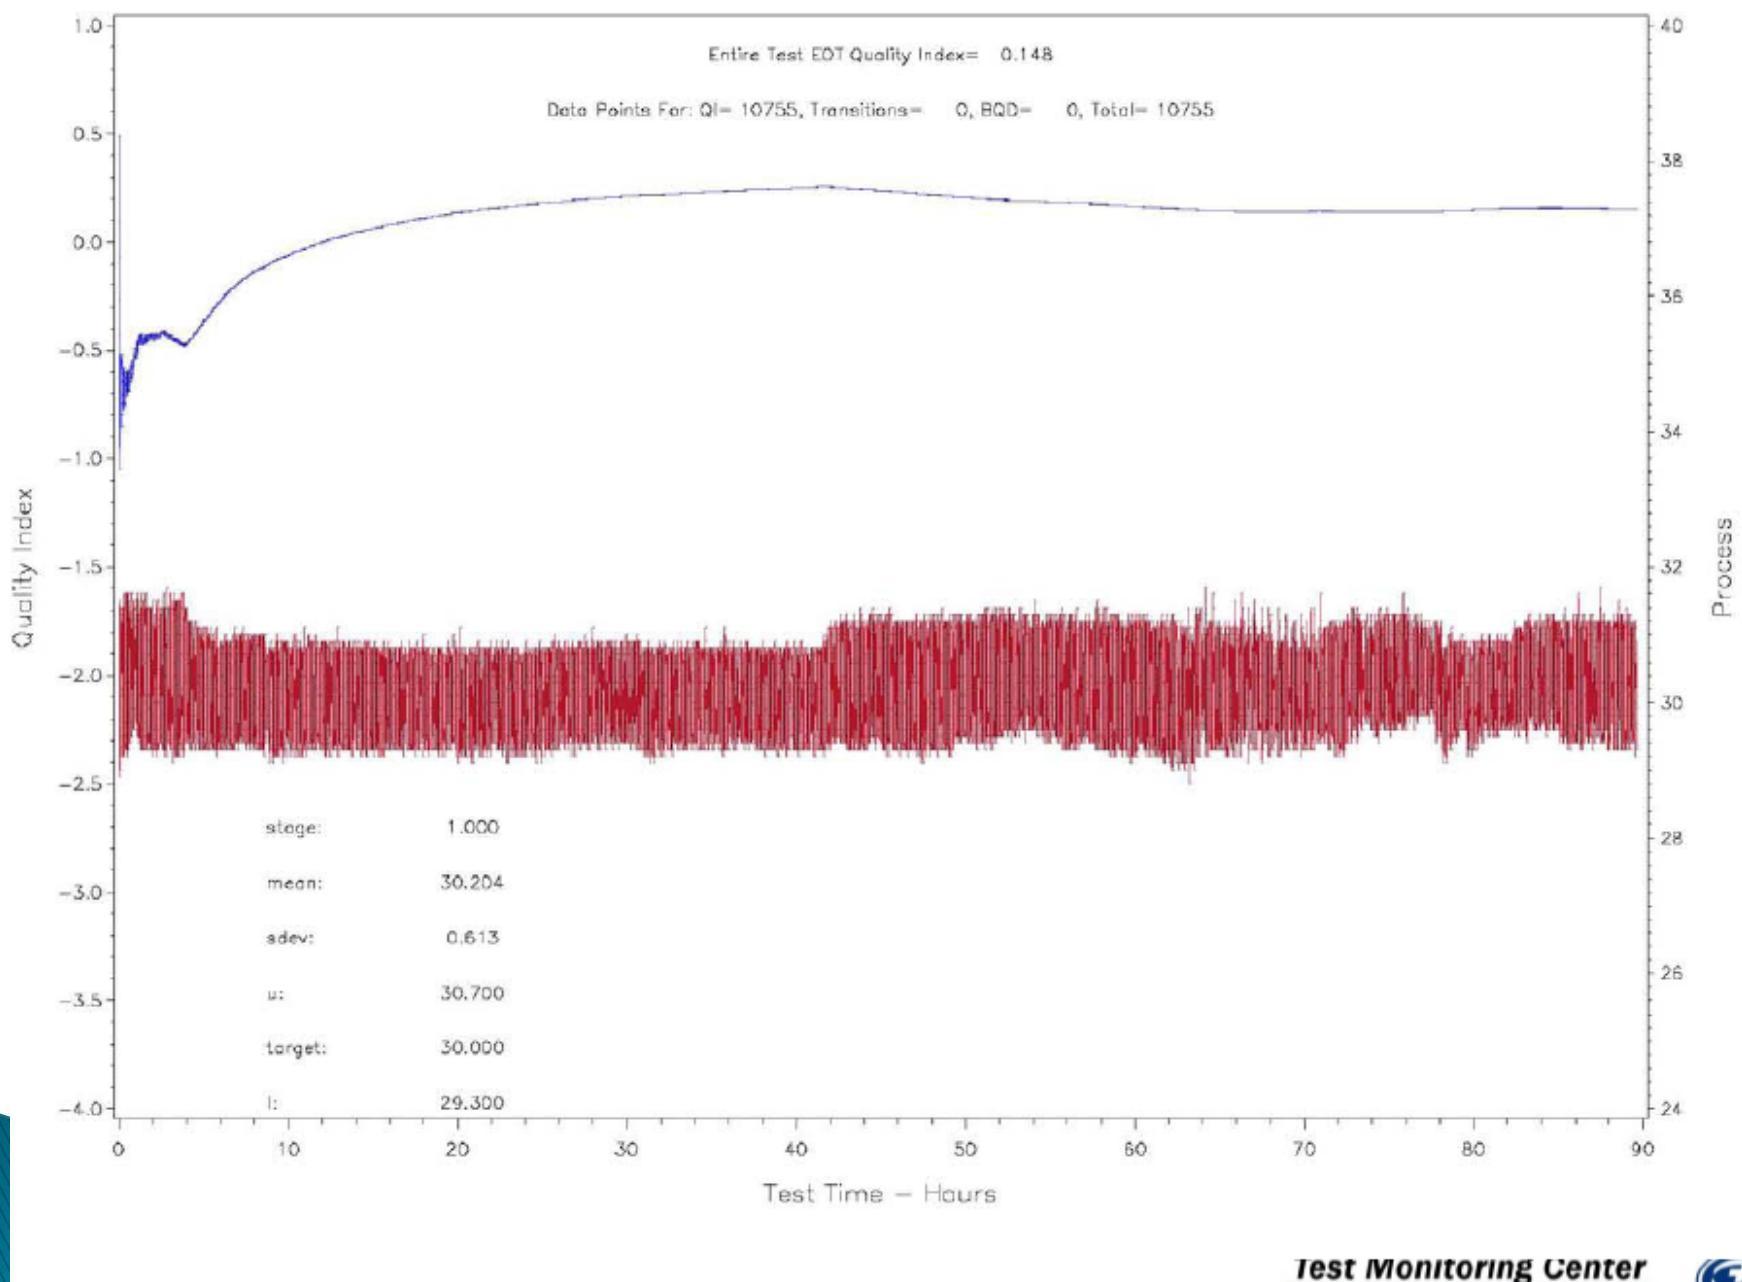
IIIH QUALITY INDEX OPERATIONAL REVIEW Fuel Inlet Temperature – Degrees C (CONTROL) LAB= D Stand= OB106 CNIR= 106791

- Fuel Temperature QI
 - The control loop is at the limit of control and highly dependent on ambient effects due to the return– less fuel system.

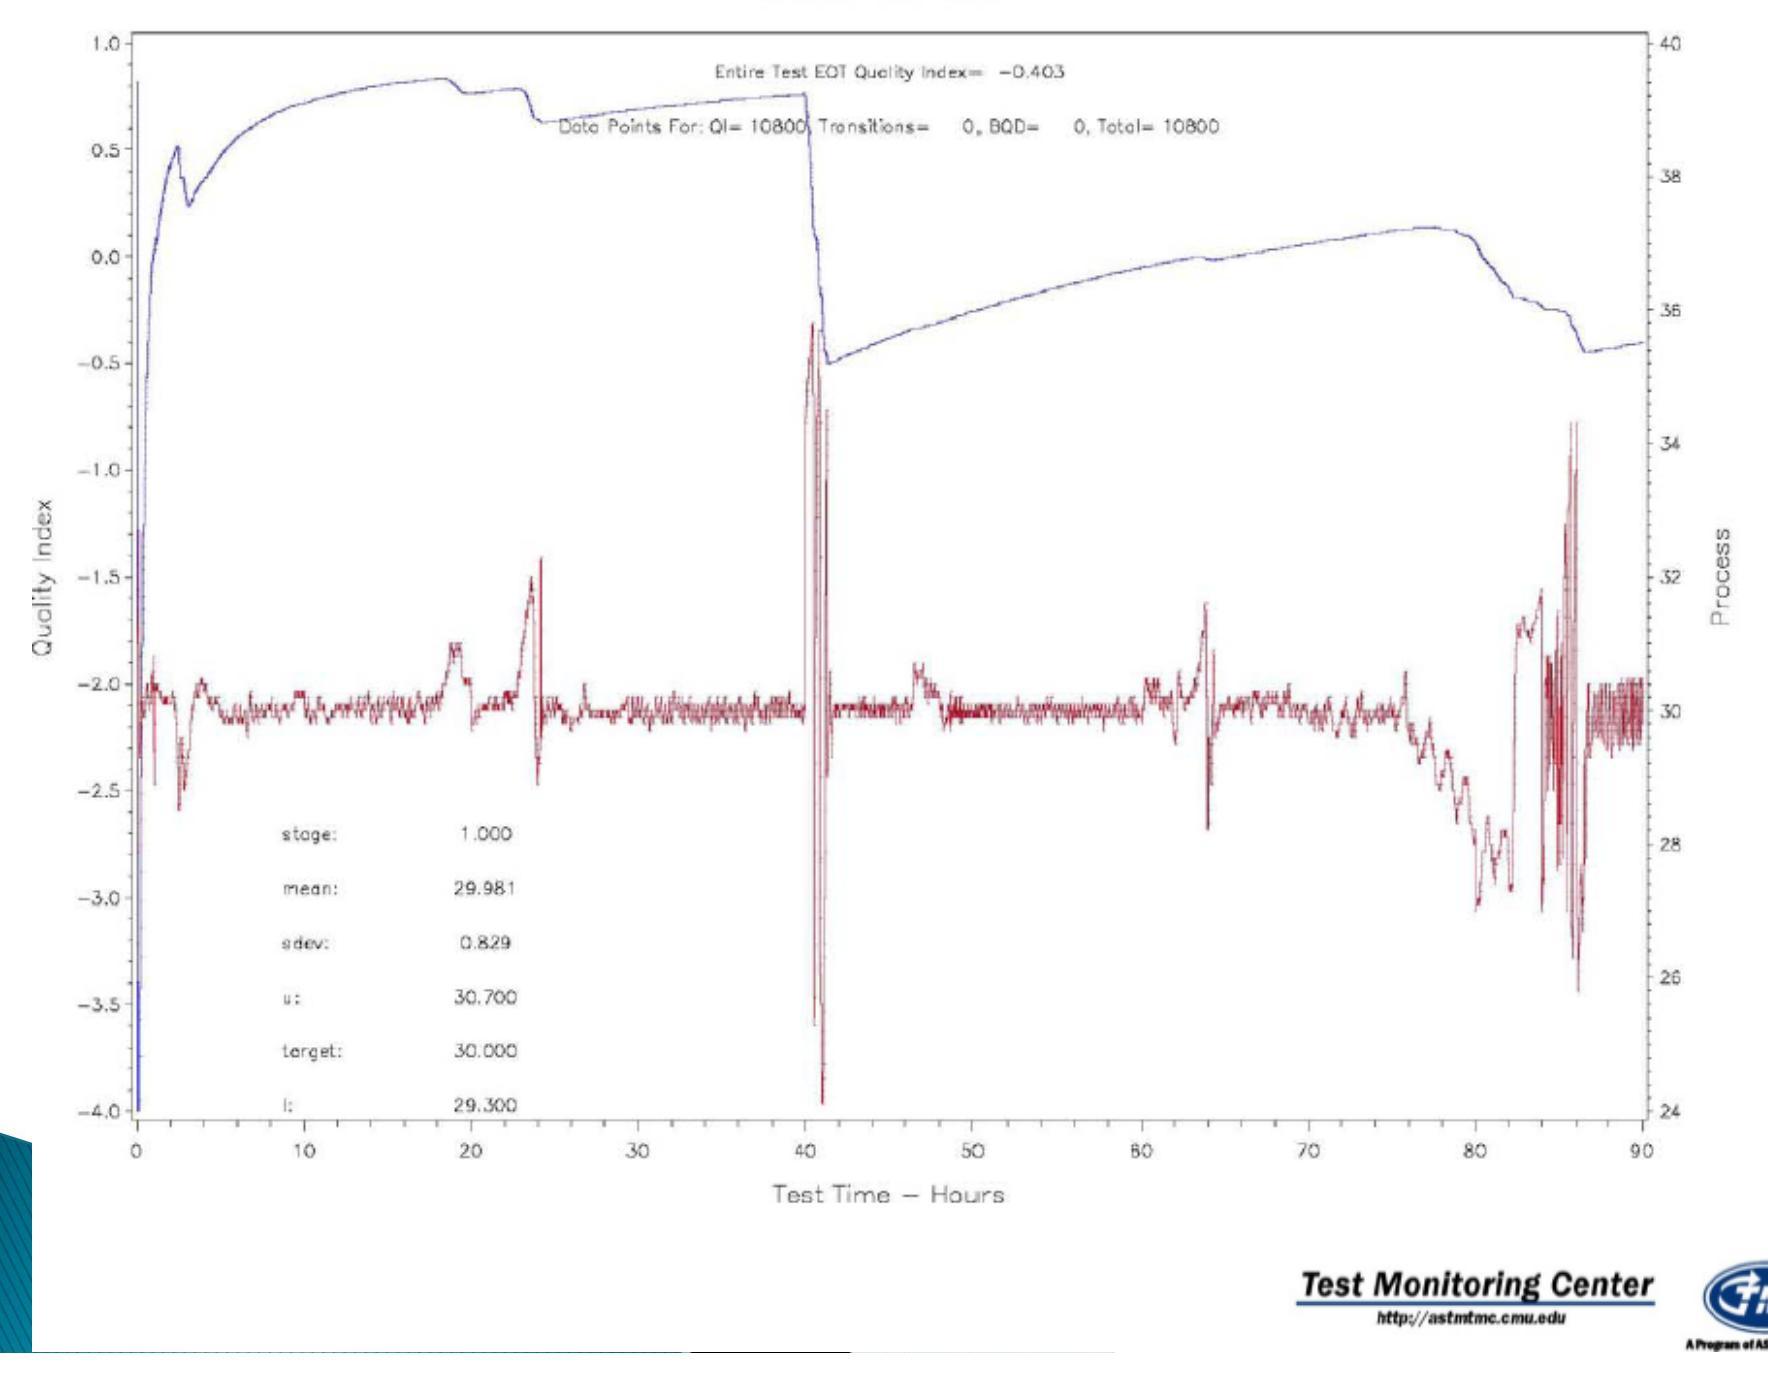
IIIH QUALITY INDEX OPERATIONAL REVIEW Fuel Inlet Temperature - Degrees C (CONTROL) LAB= A Stand= 2 CNIR= 106776

- Fuel Temperature QI
 - Control issues were experienced due to ambient temperature effects.

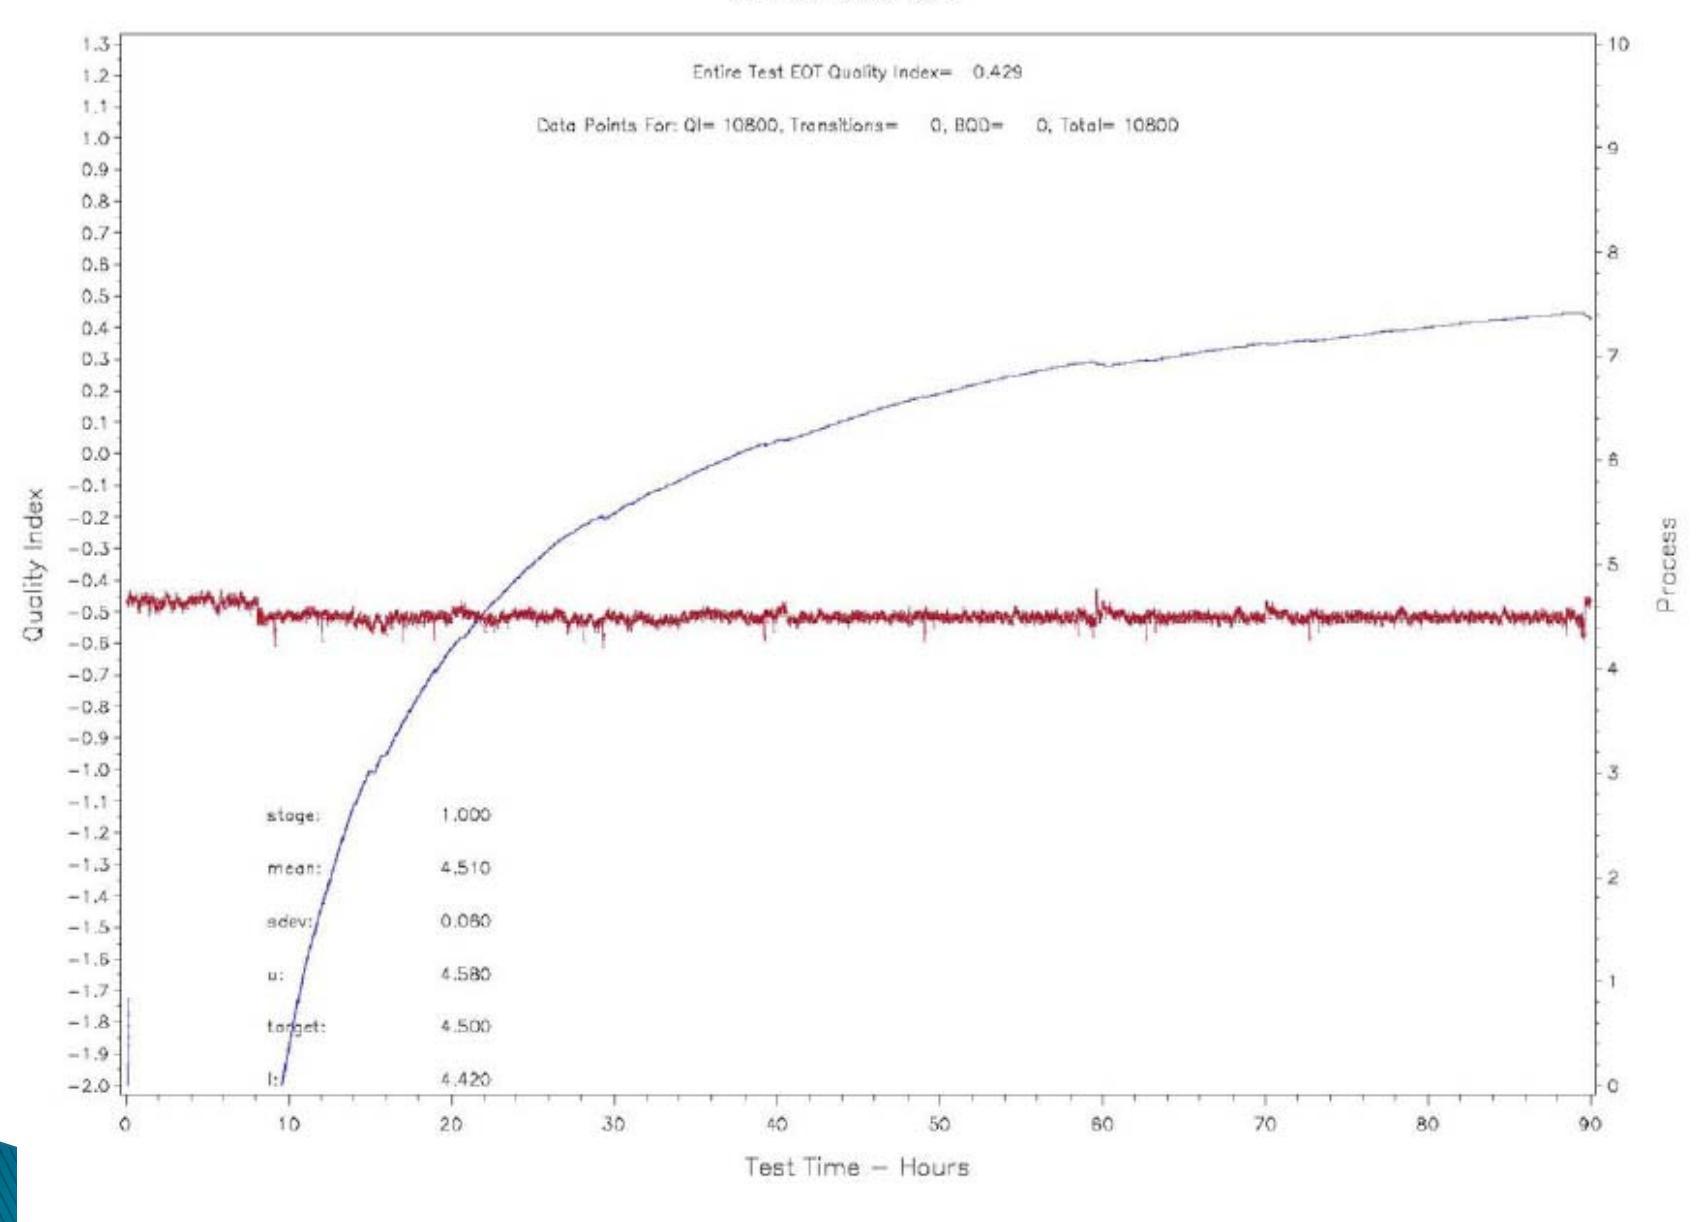
IIIH QUALITY INDEX OPERATIONAL REVIEW Exhaust Back Pressure Left -- kPa (CONTROL) LAB= E Bland= 3 CMR= 106761

- Left Exhaust Back Pressure QI
 - Exhaust back-pressure valve actuator lower limit was spanned Incorrectly which prevented it from opening fully to lower the exhaust back pressure. It was corrected at test hour 5 by test Engineer. This test did end with a positive QI (0.429).
