IIIH PM Op Data Review Fourth Round of IIIH PM Tests

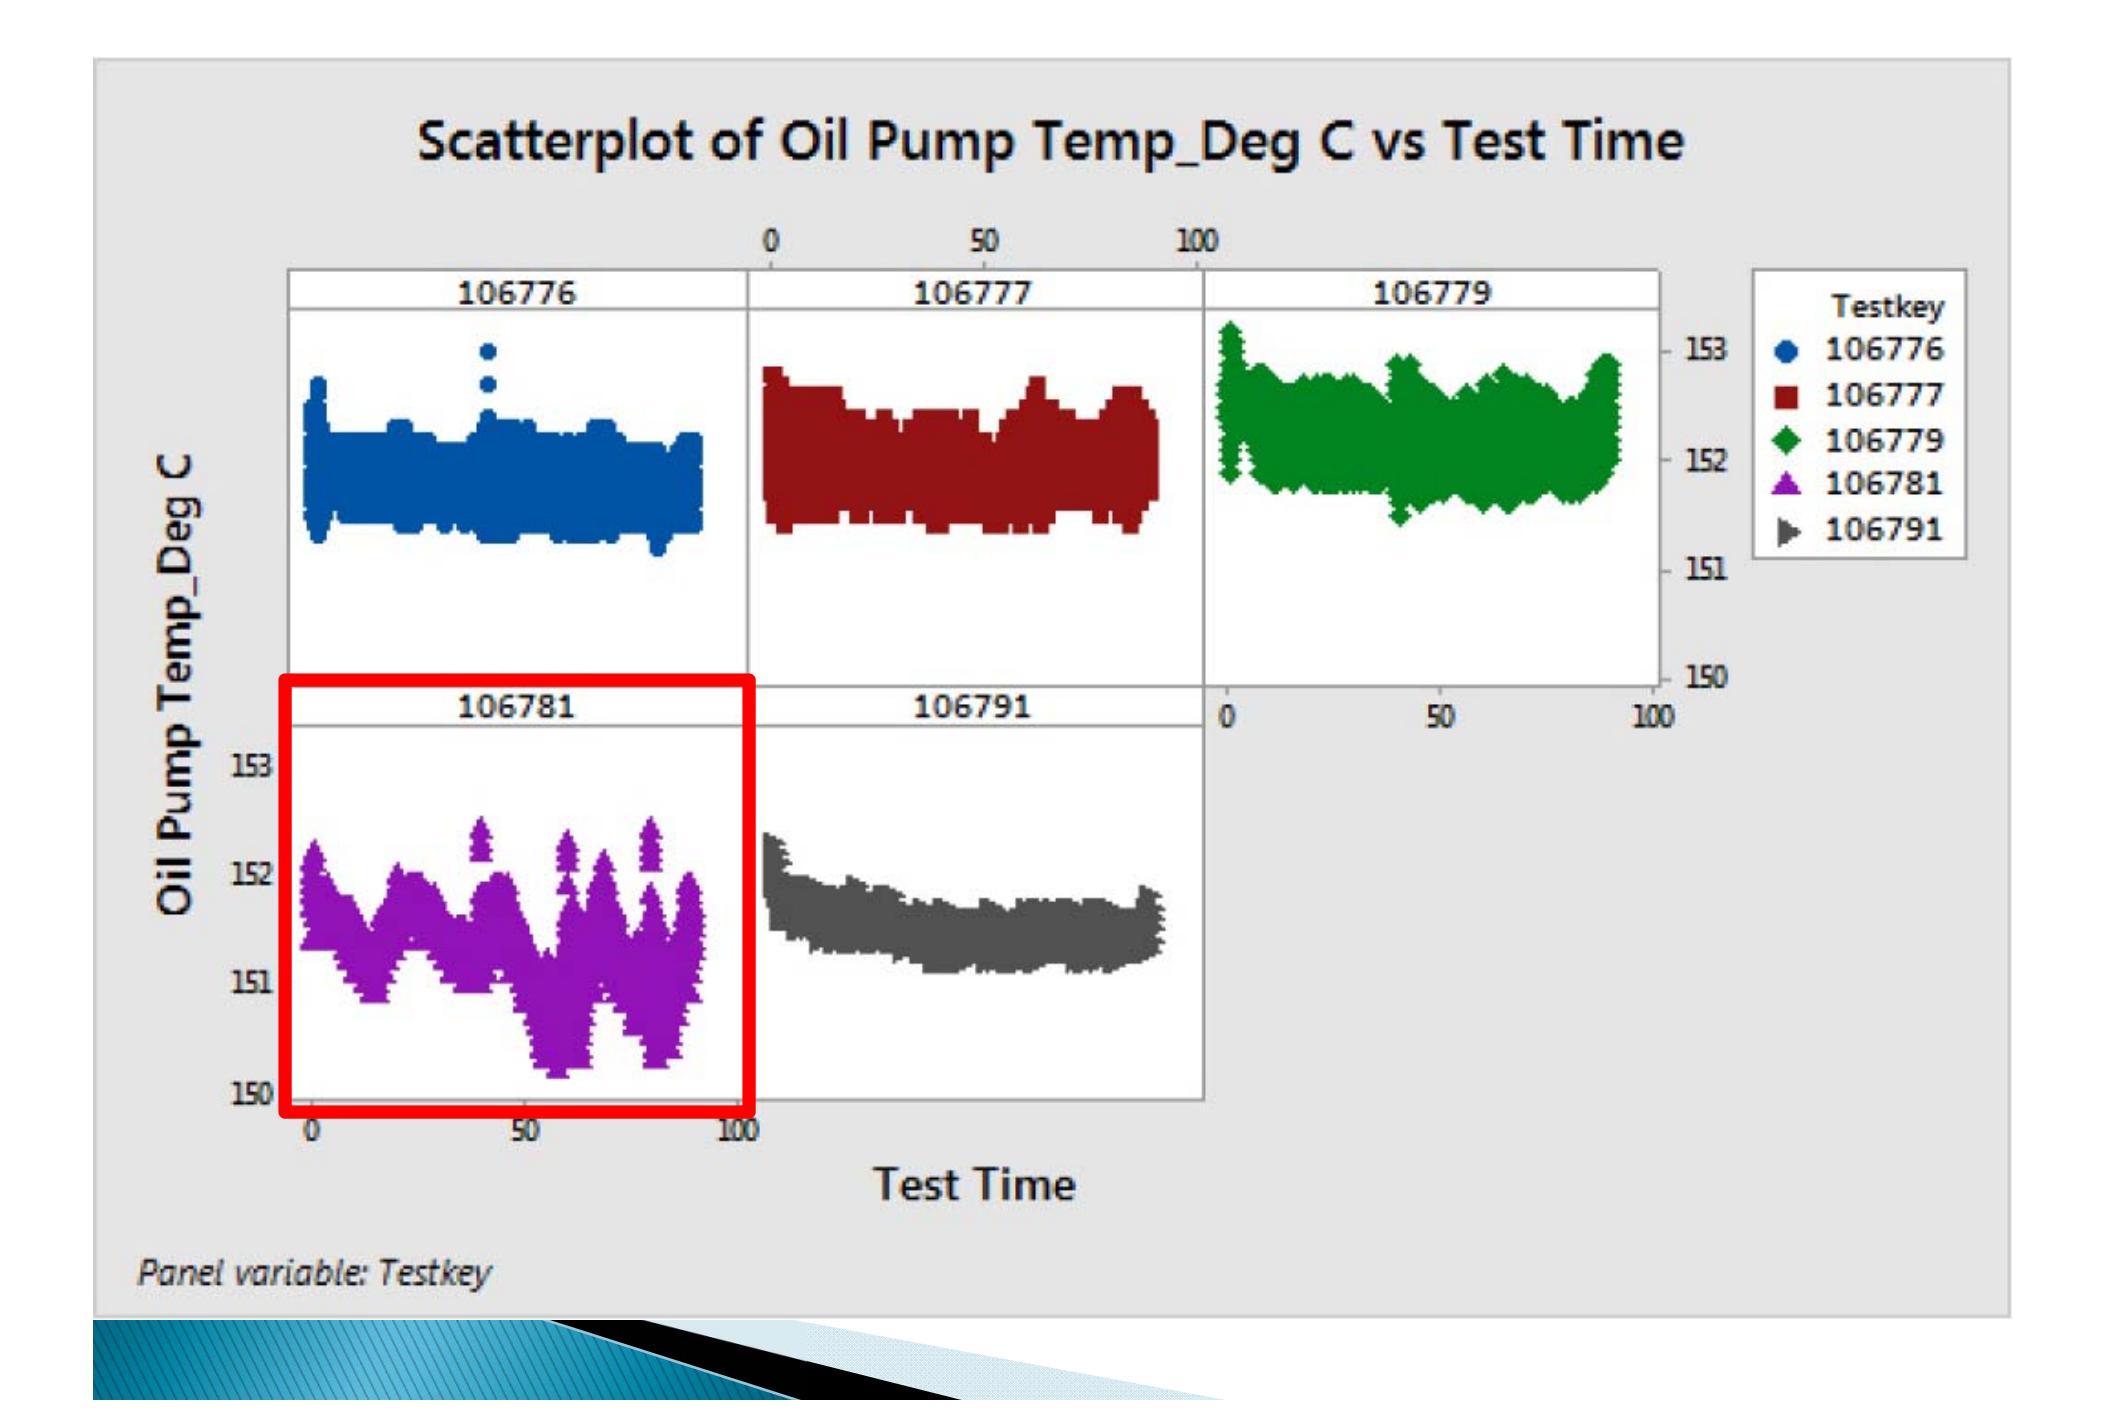
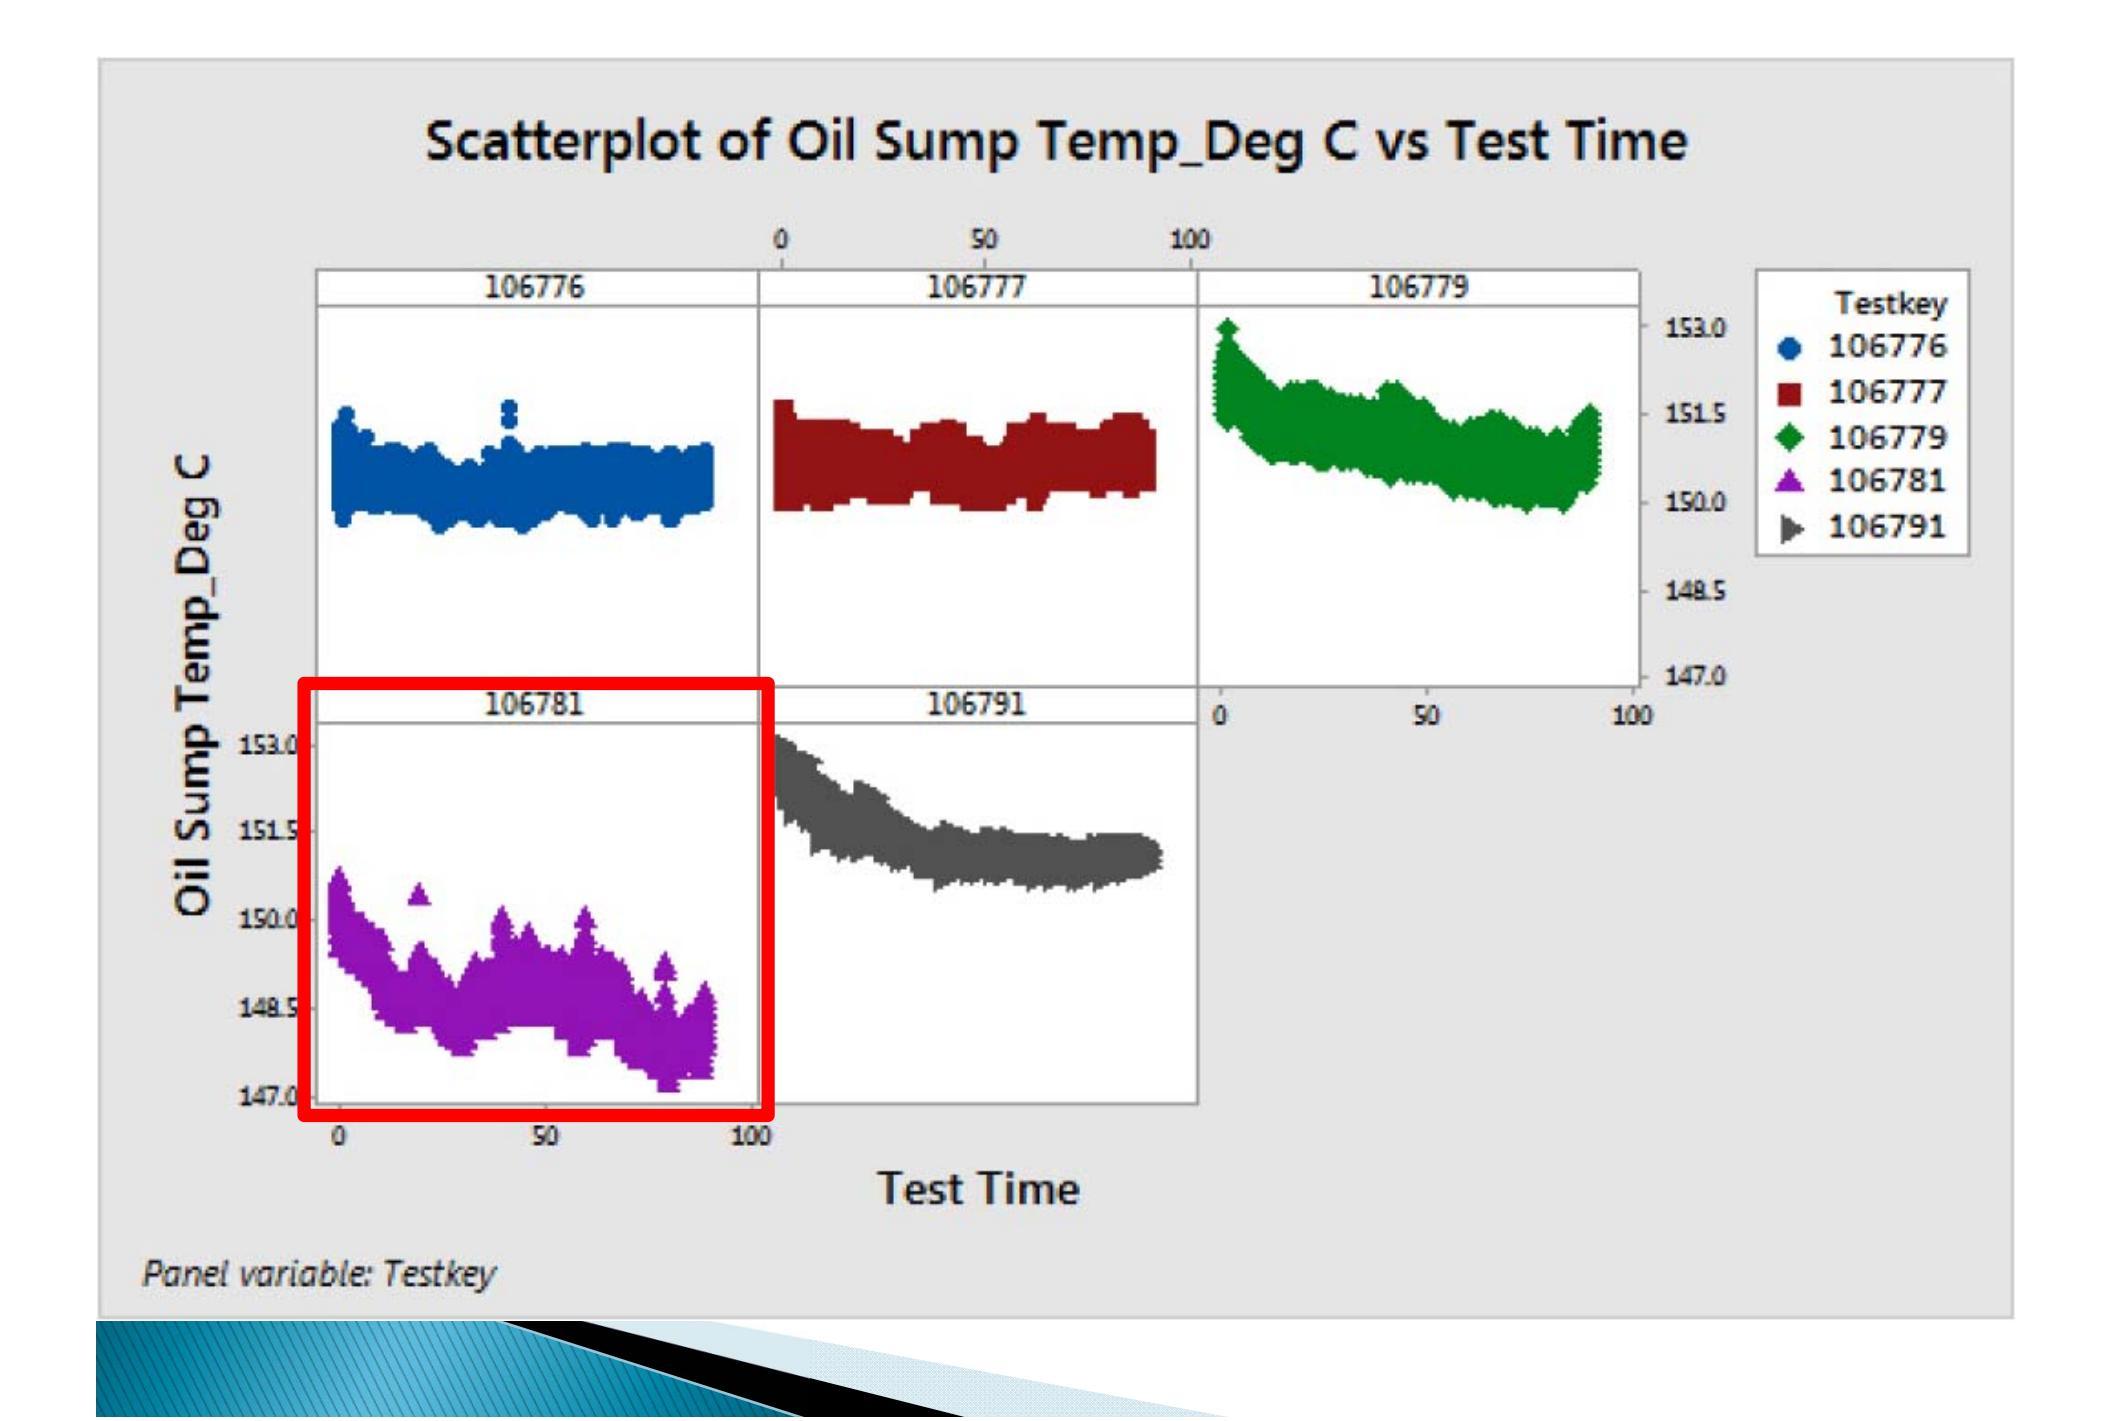
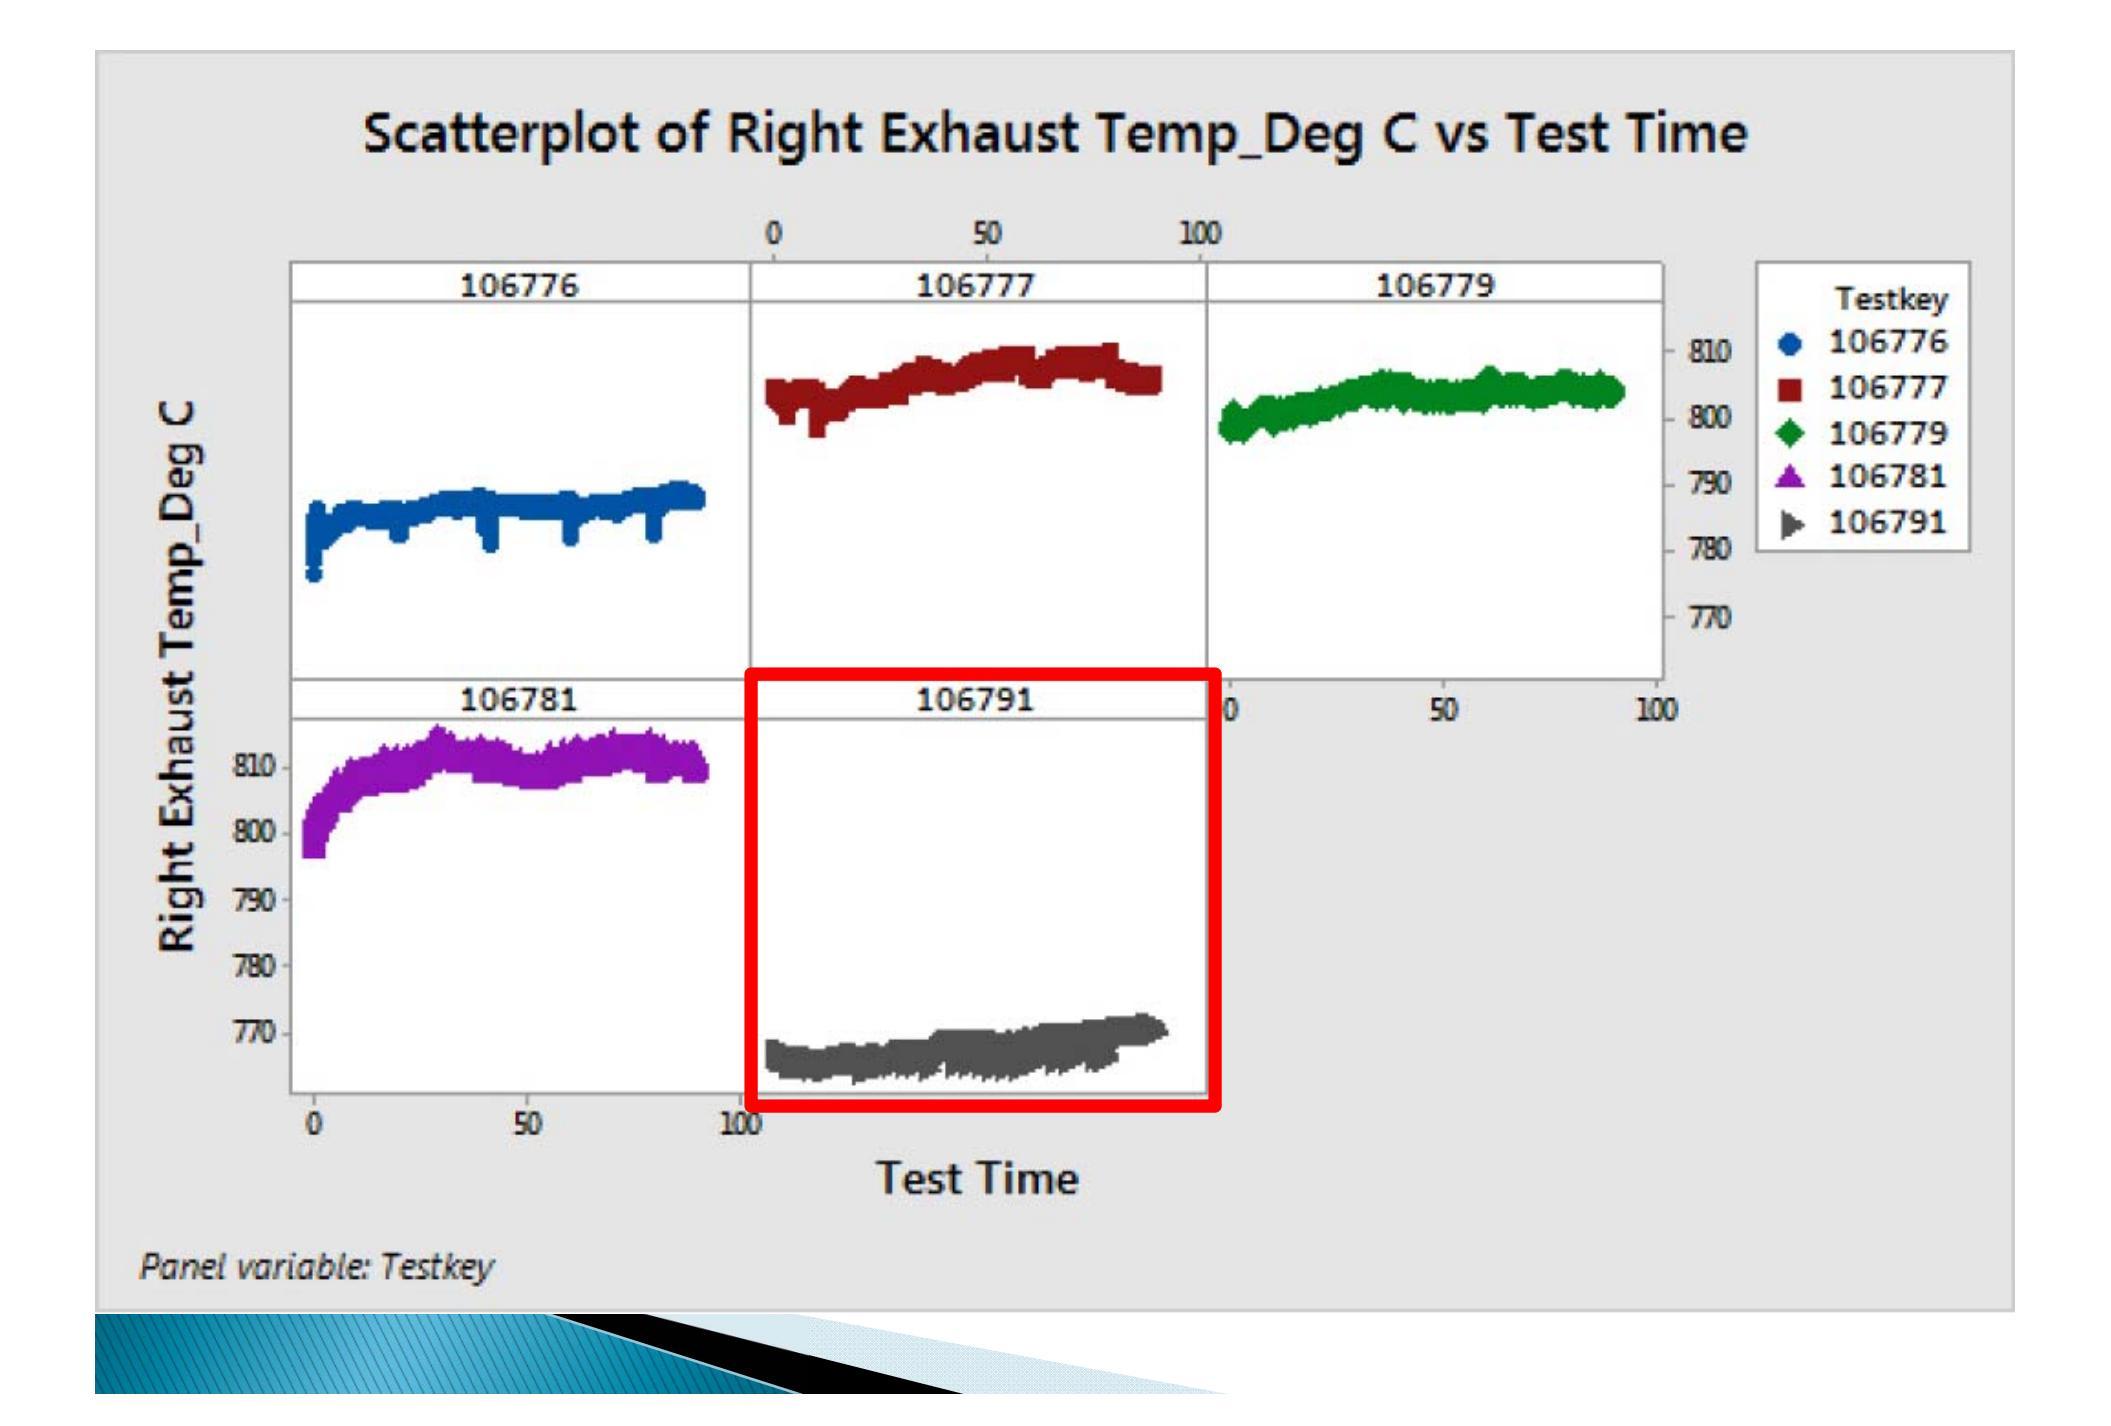
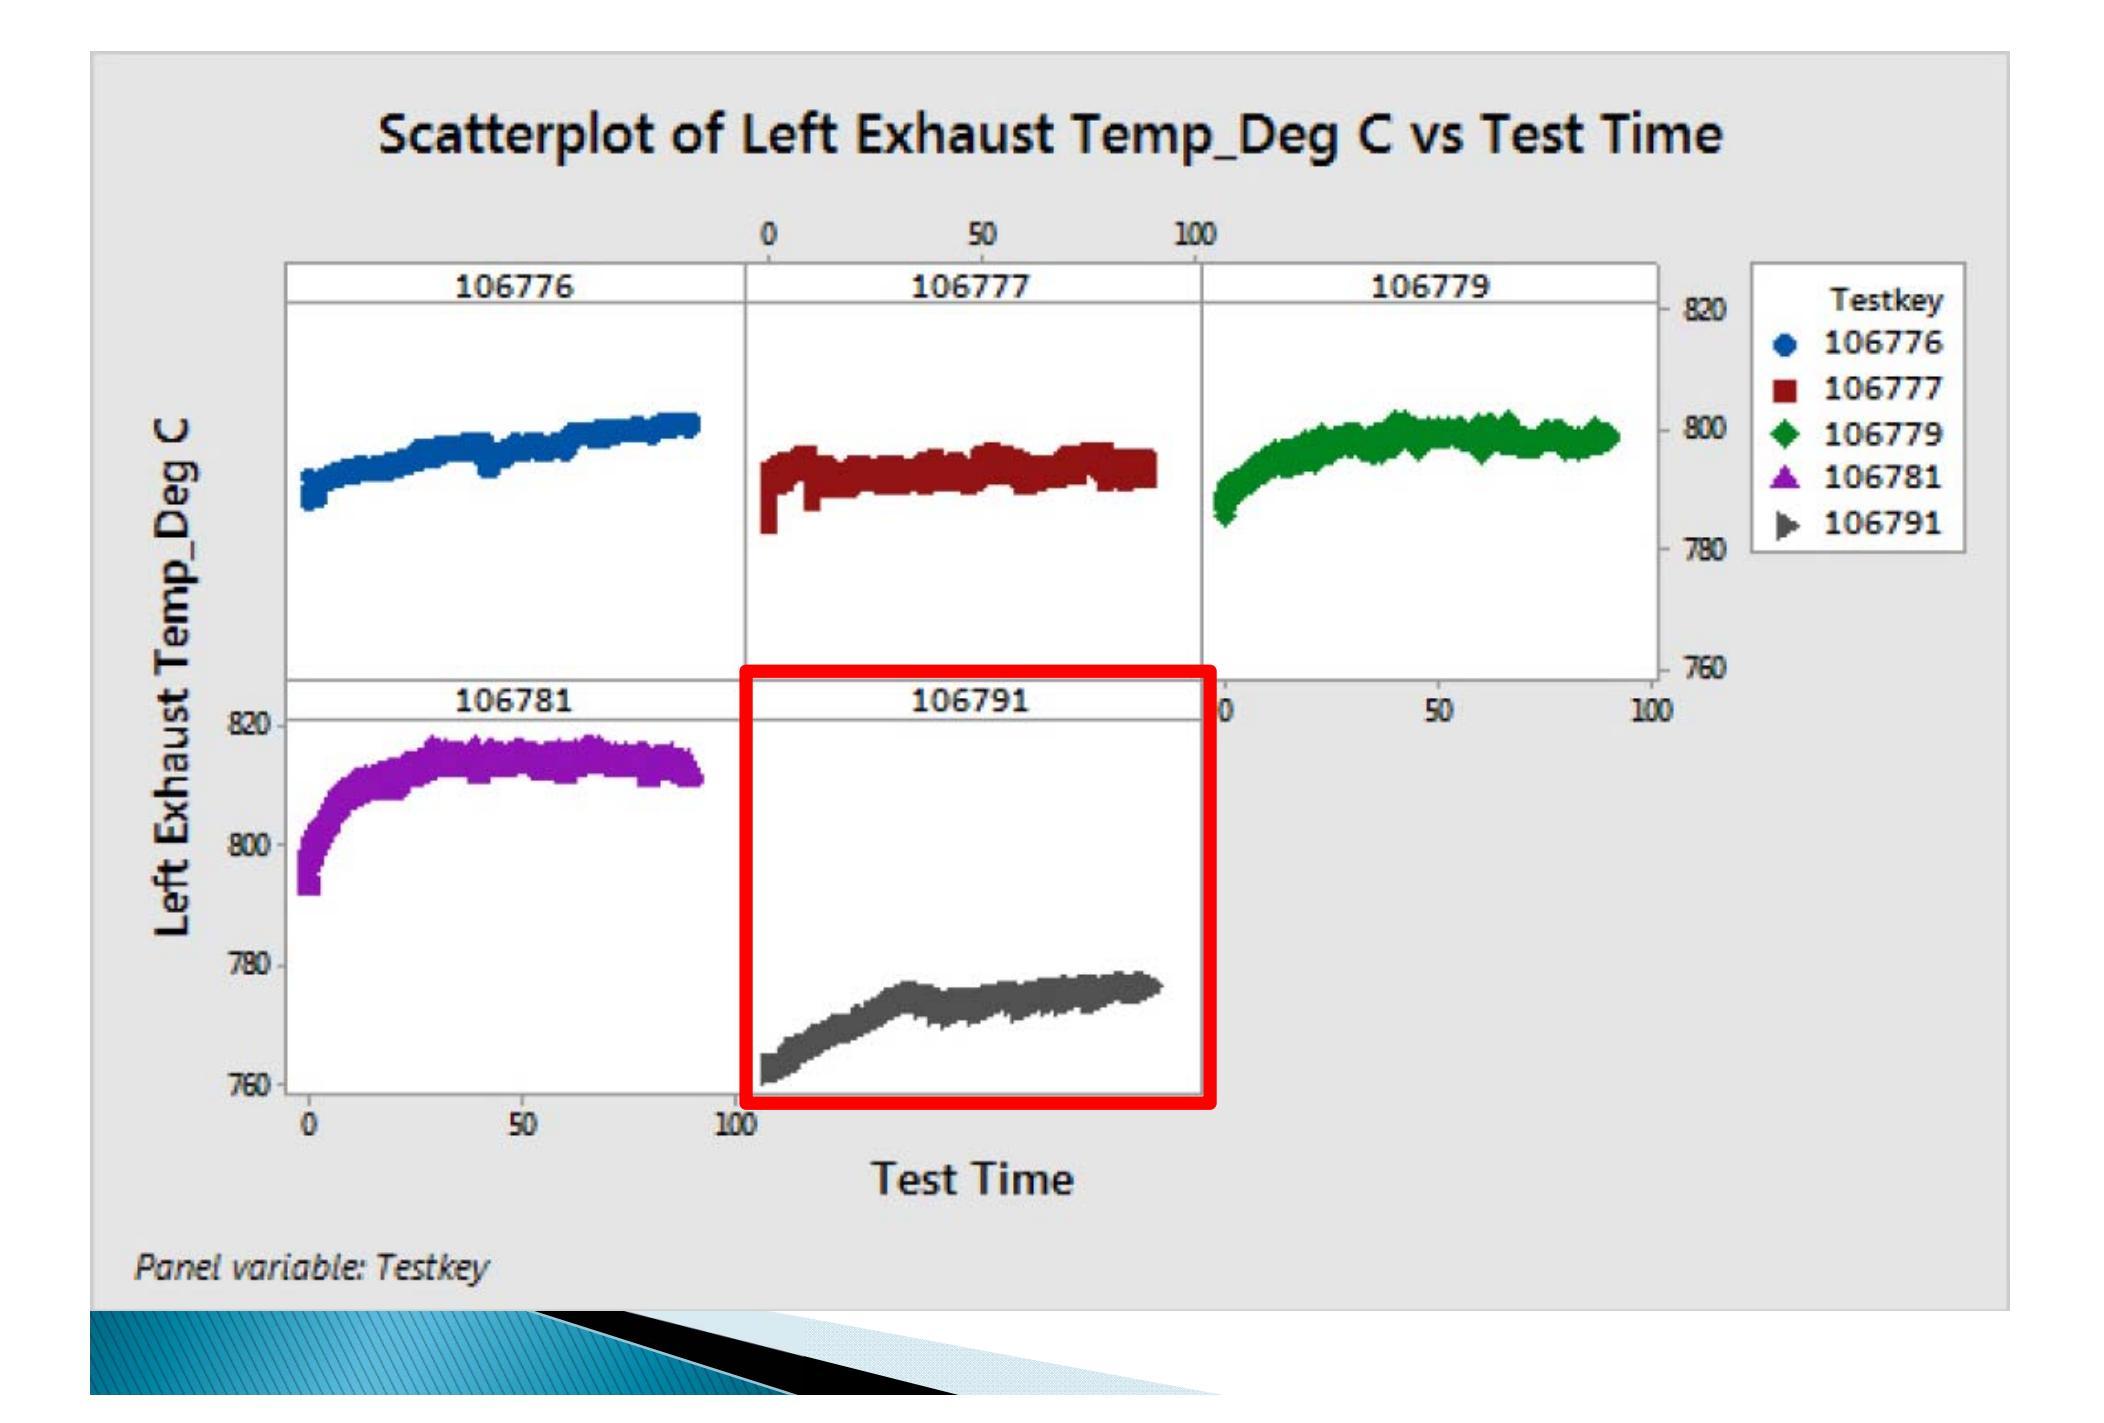
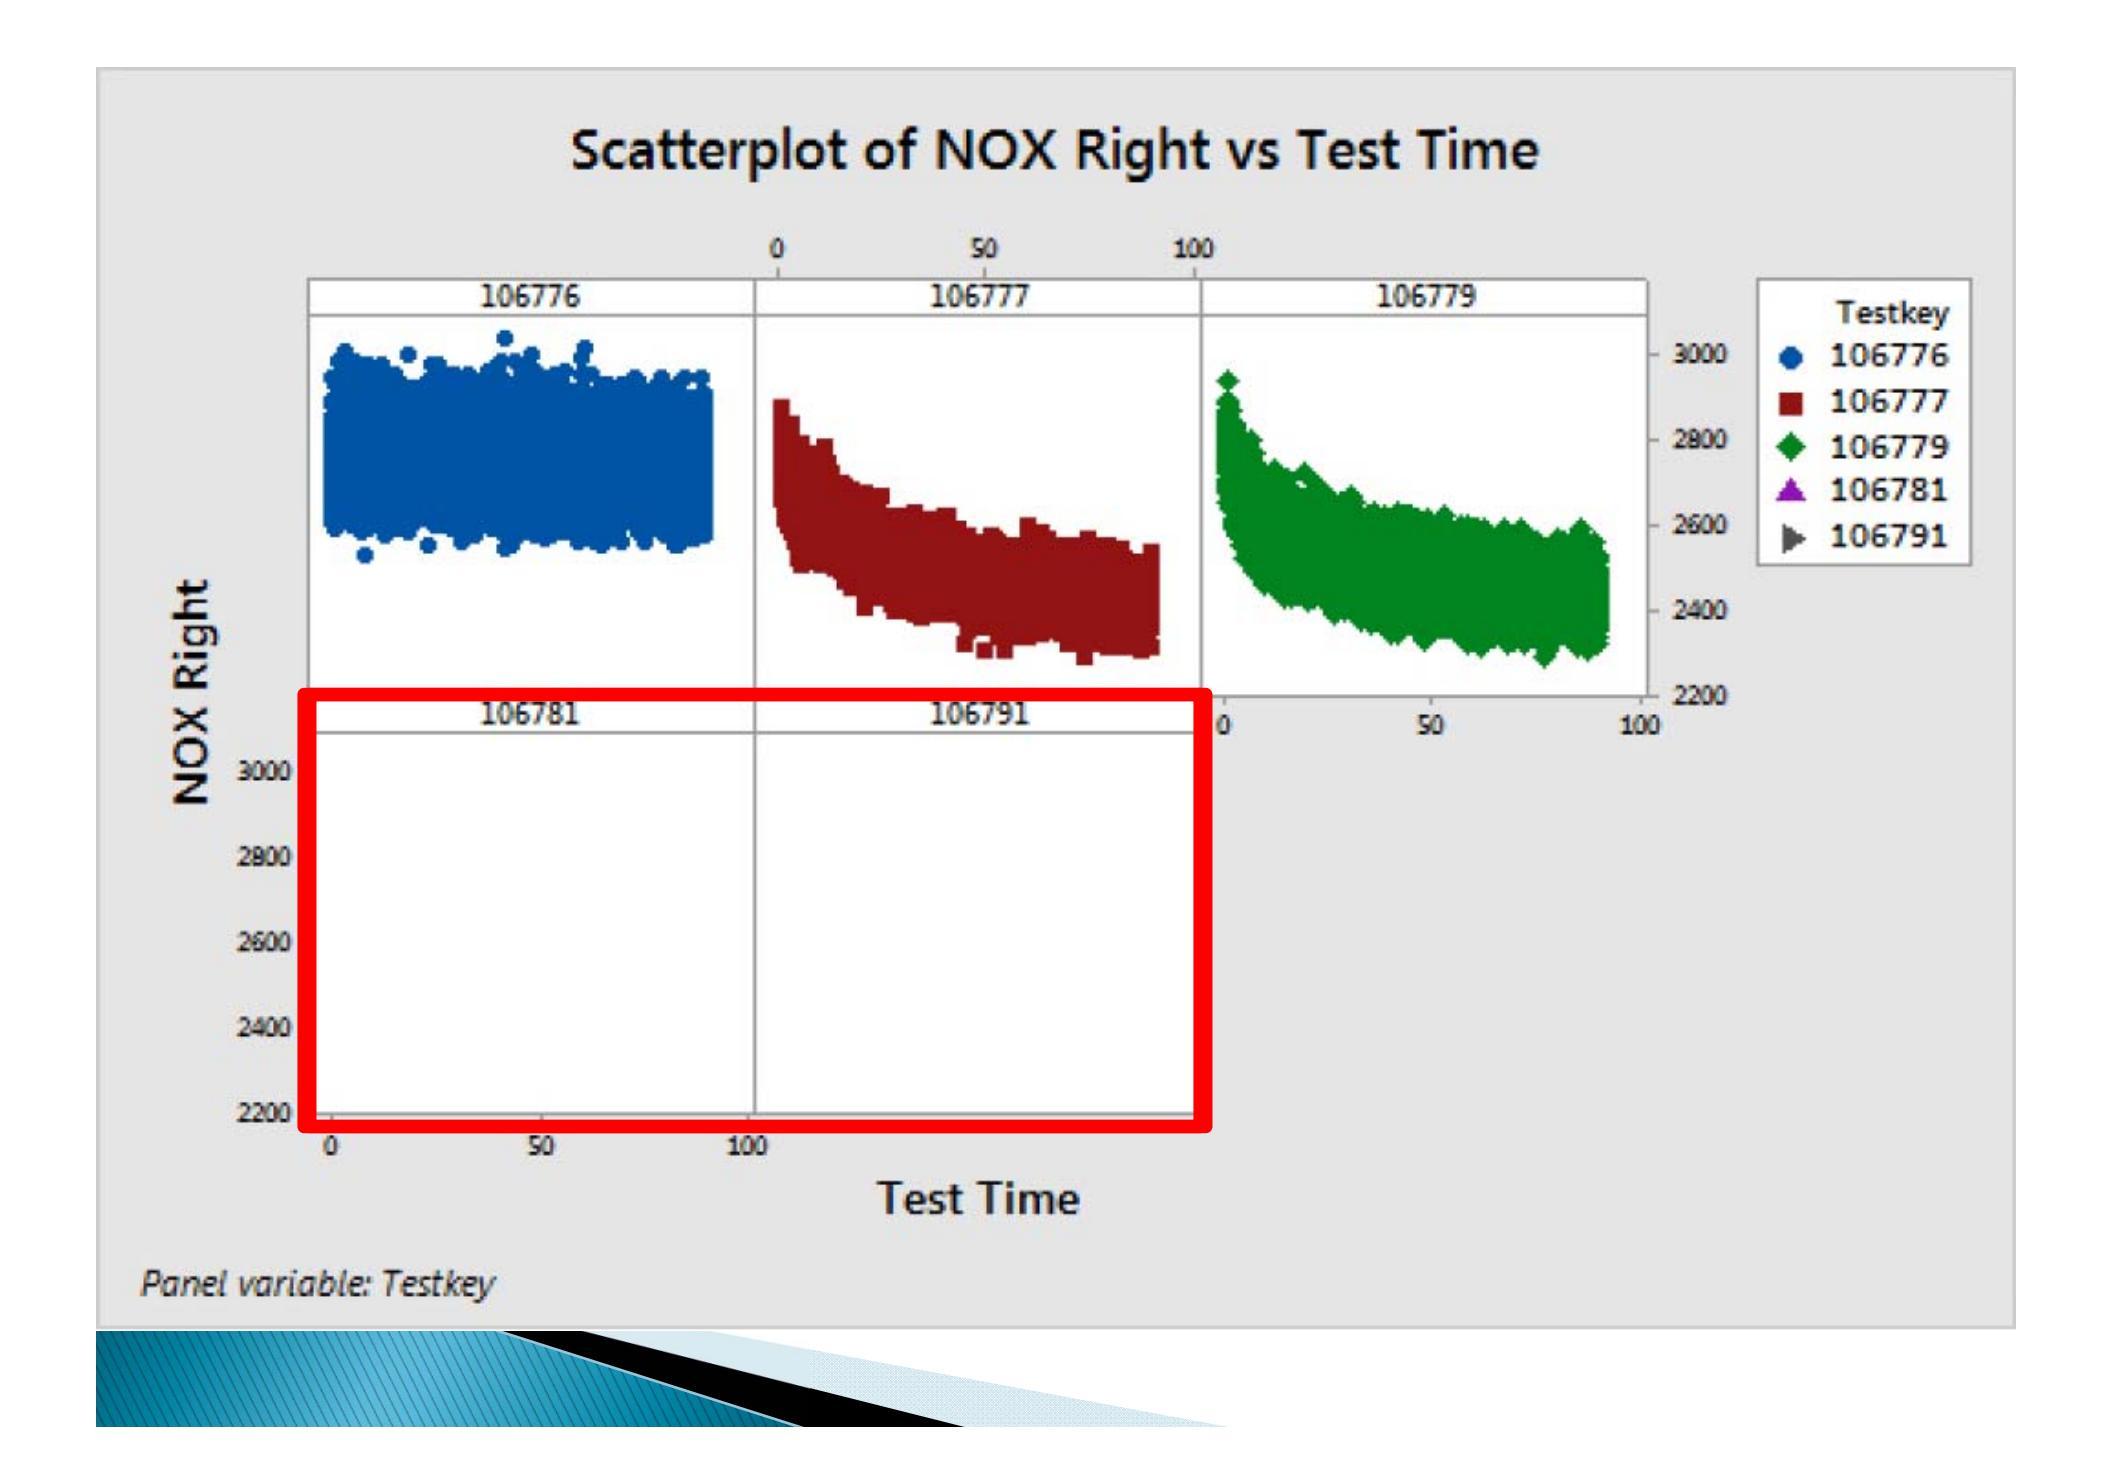
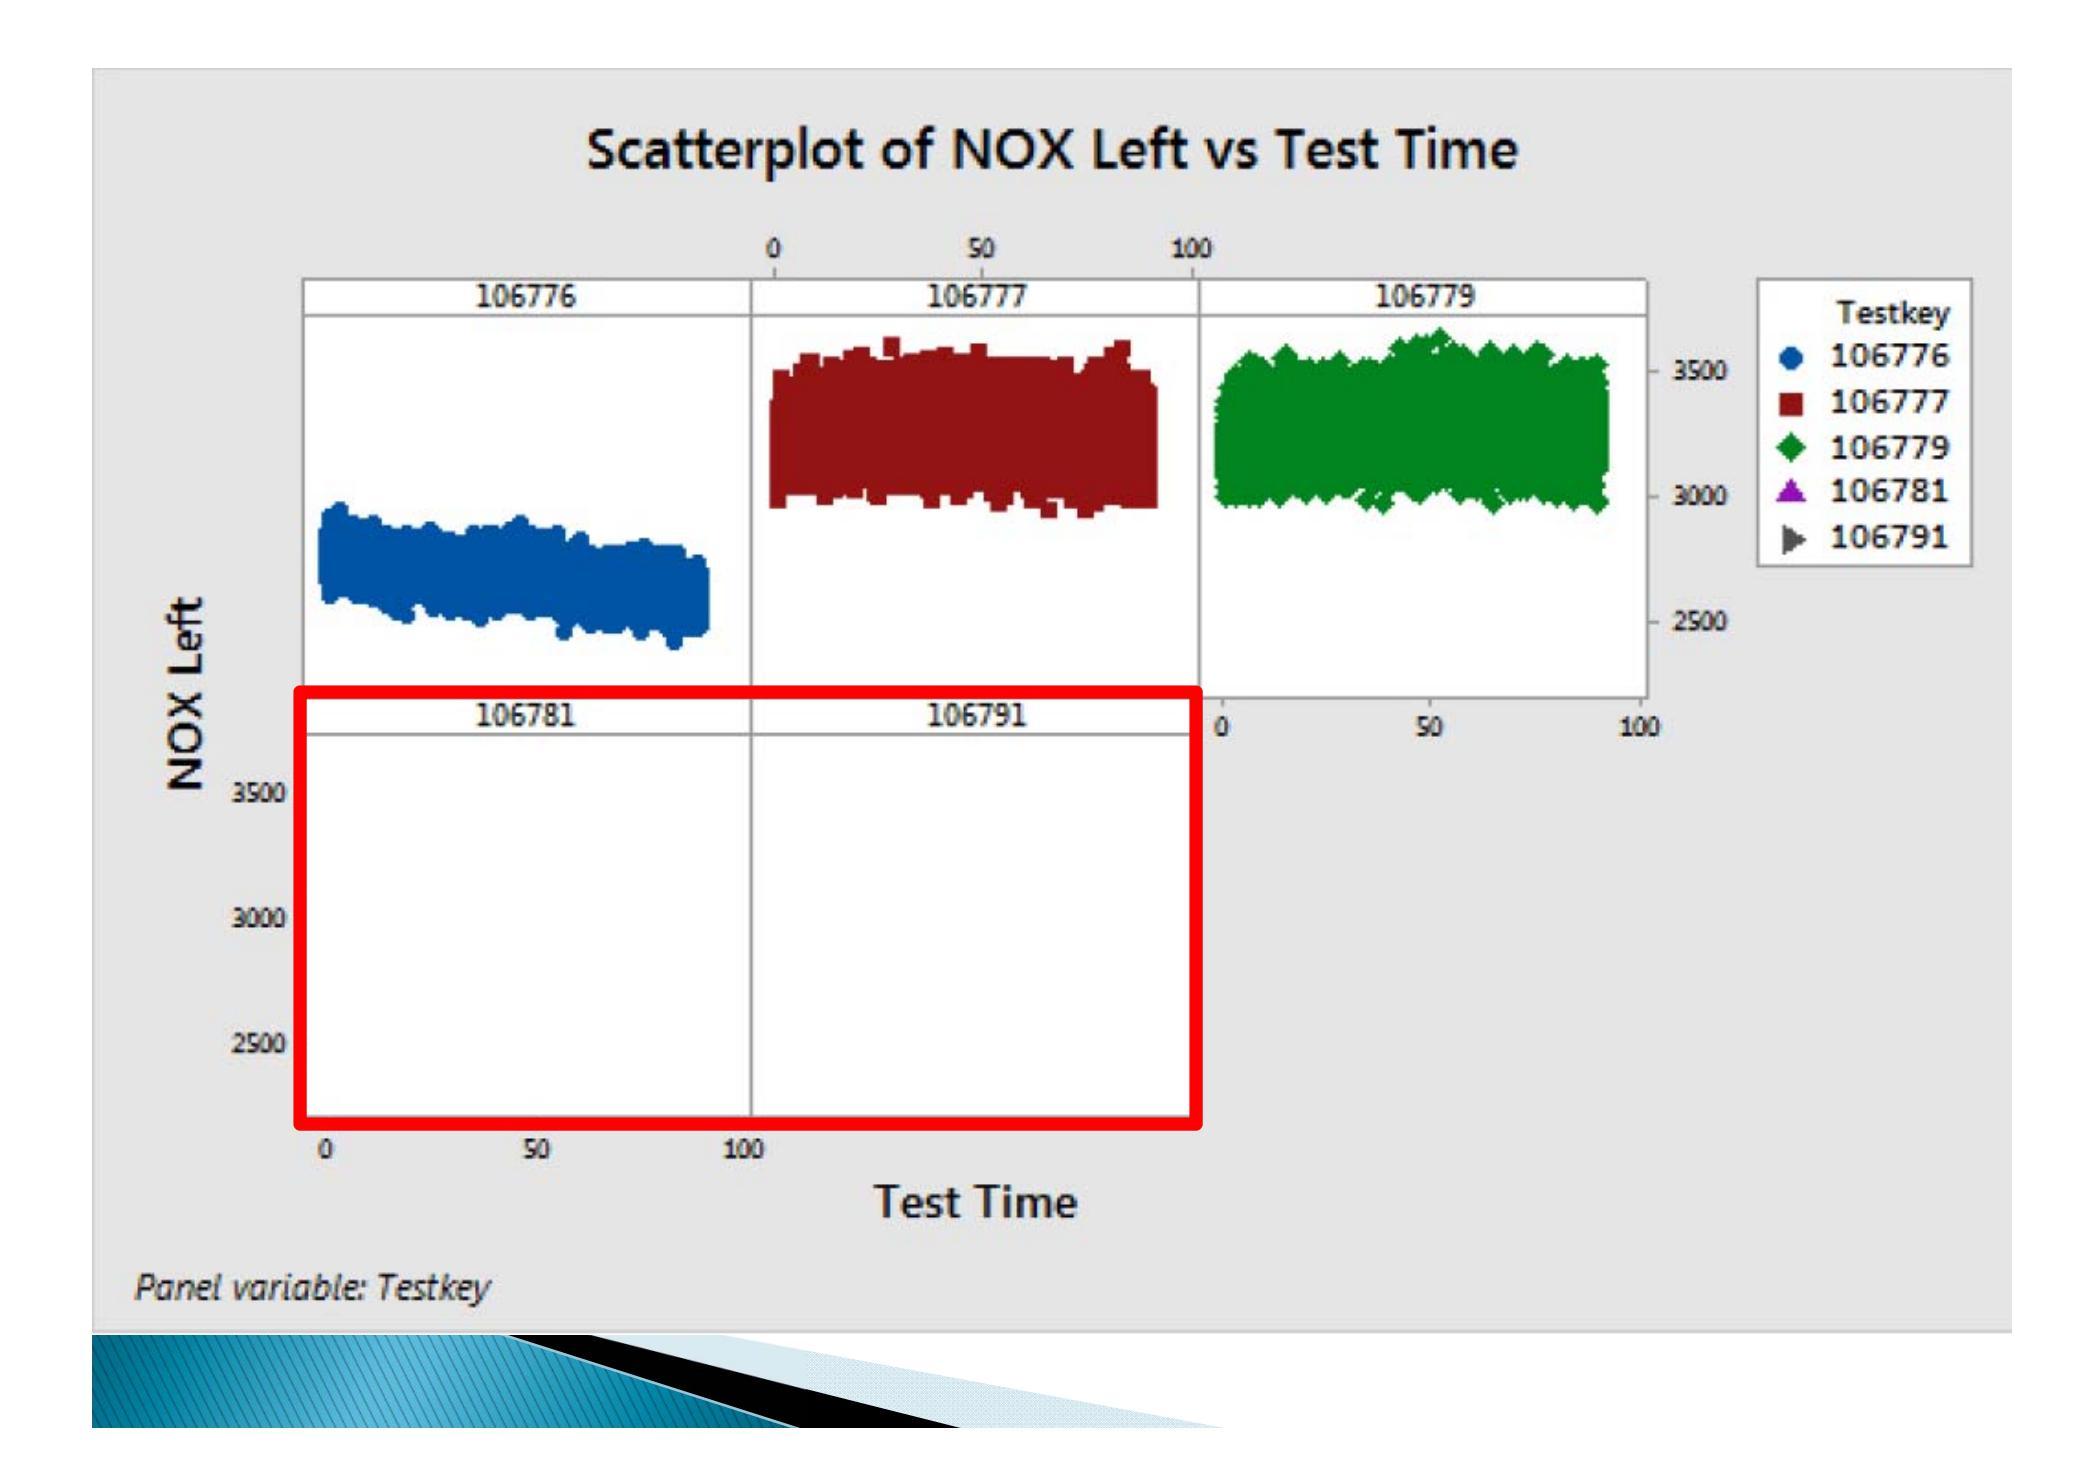
- Found -1.3°C offset relative to T-block control temp. Large ambient temp. swings were also observed (75F to 57F for 1st 2 days and 80 F to 47 F for last 2 days) believed to be cause of undulations observed.
- Oil Sump Temperature
 - Found -1.3°C offset relative to T-block control temp. This thermocouple might have been in the wrong drain plug hole (on the side of pan instead of under-bottom of the pan). These exceptions believed to have been the cause of Oil Sump Temp. showing lower than others.
- NOx Left and Right

NOx gas analysis was performed manually and not with a real time NOx sensor.

- Right and Left Exhaust Temperature
 - Fans are utilized per procedure to cool the exhaust turndown pipes. This parameter is also highly dependent on thermocouple insertion depth.
- NOx Left and Right
 - NOx gas analysis was performed manually and not with a real time NOx sensor.
