#### **Cummins M11 Filter Plugging**

#### **M11EGR Filters**

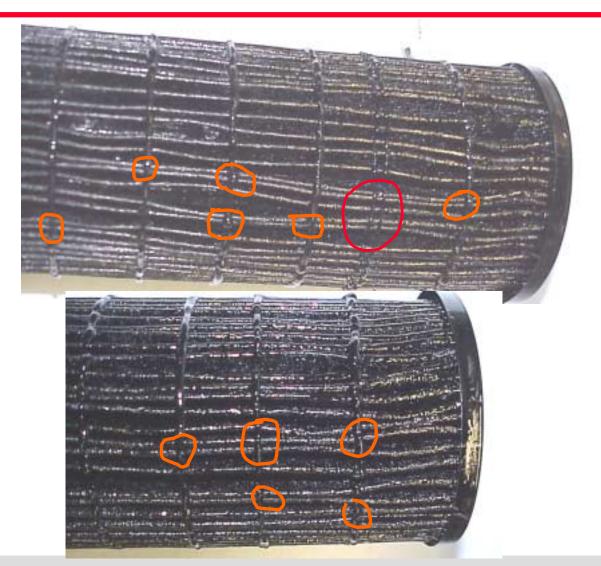
- Oronite has observed variable filter performance in recent testing
- Filters have been examined to determine cause
- We observe that filters with high pressure have had the pleats glued together

Improve filter pleat spacing consistency
