# Pitted Batch O Camshaft Results

SOUTHWEST RESEARCH INSTITUTE®

FUELS & LUBRICANTS RESEARCH

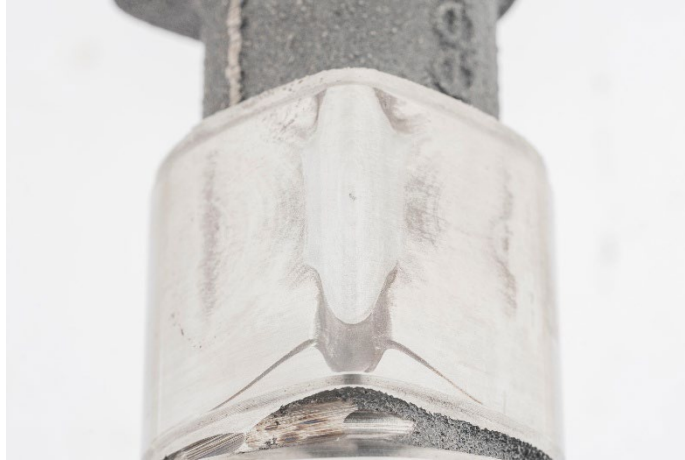
CMIR-196522: 46.3  $\mu\text{m}$

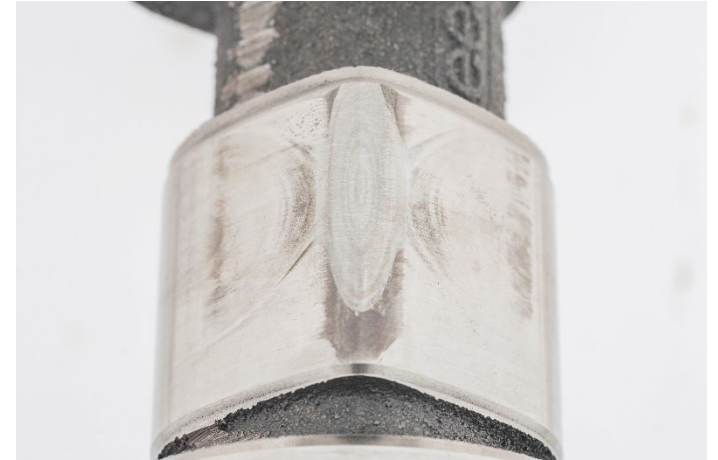
CMIR-195526: 41.7  $\mu\text{m}$

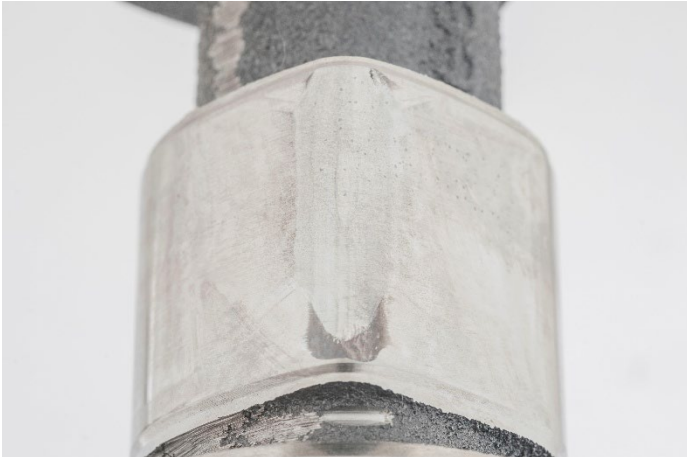
CMIR-195527: 44.0  $\mu\text{m}$

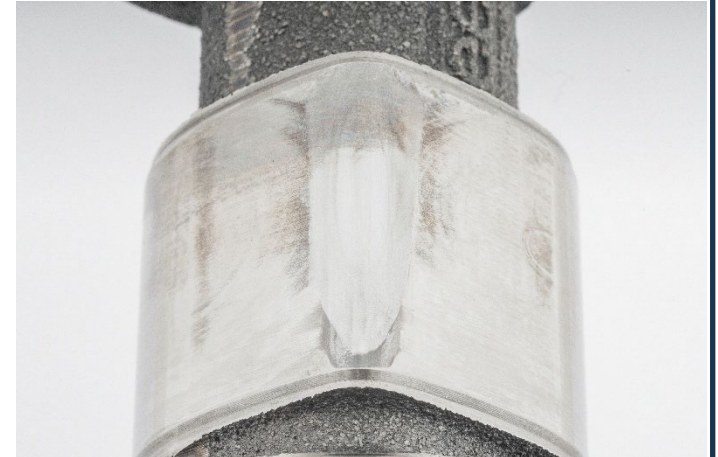
CMIR-202553 EOT: 70.3  $\mu\text{m}$

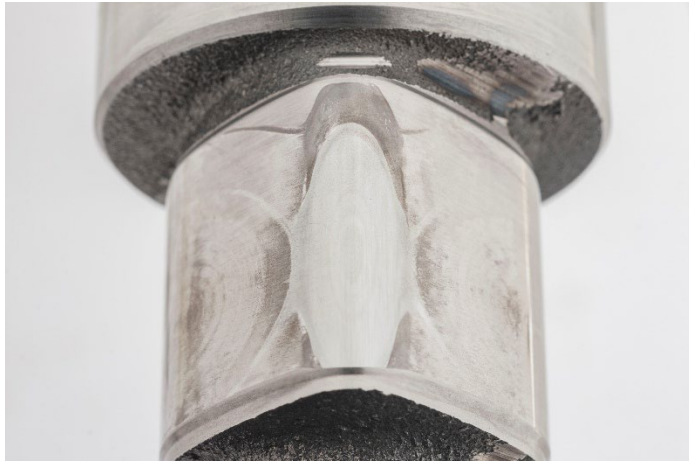
CMIR-196523: 40.0  $\mu\text{m}$

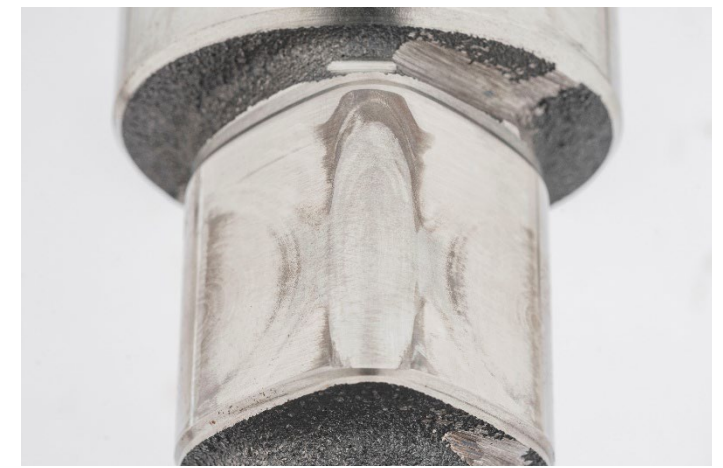
CMIR-195526: 41.3  $\mu\text{m}$

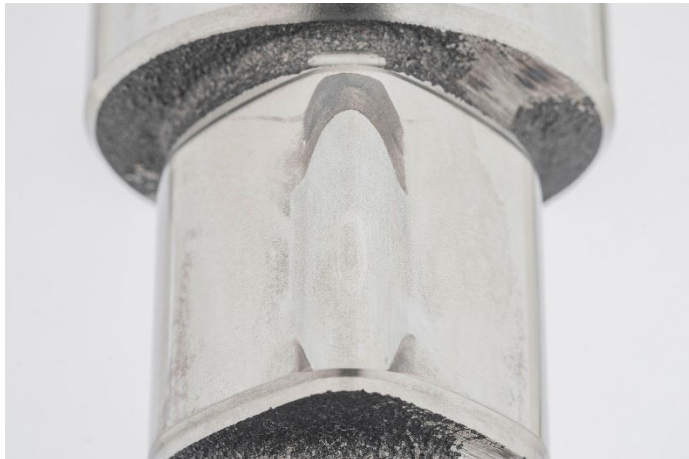
CMIR-195527: 44.3  $\mu\text{m}$

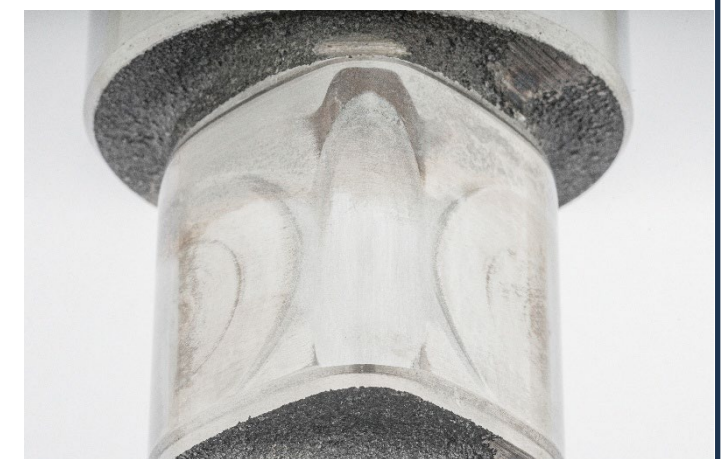
CMIR-202553 EOT: 34.7  $\mu\text{m}$

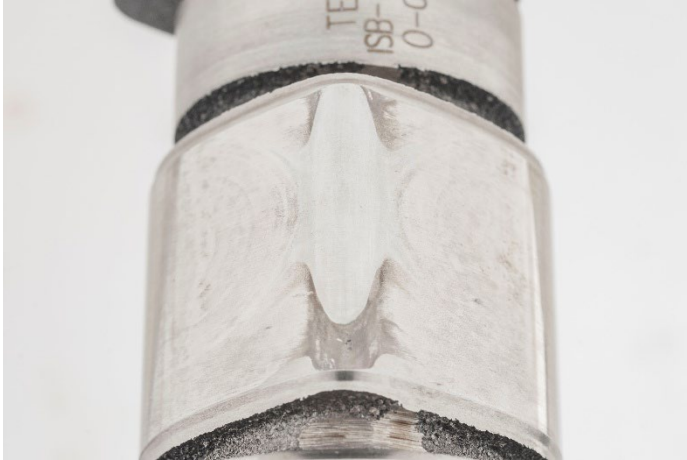
CMIR-196523: 39.7  $\mu\text{m}$

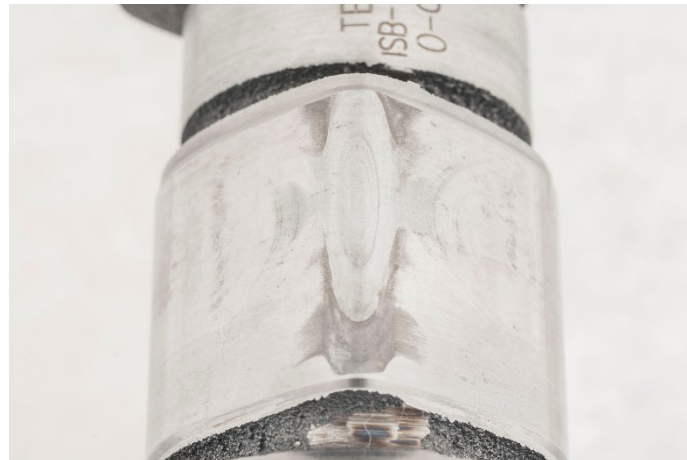
CMIR-196522: 48.0  $\mu\text{m}$

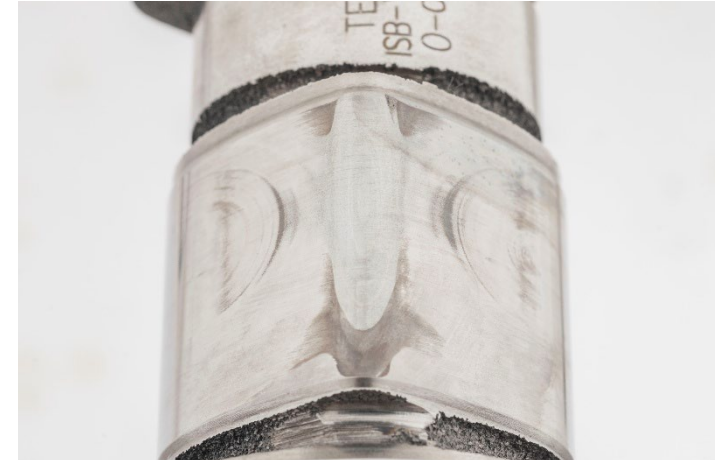
CMIR-195526: 36.3  $\mu\text{m}$

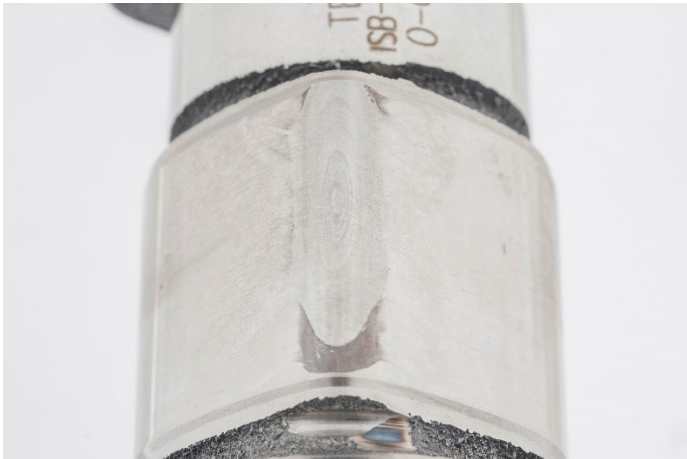
CMIR-195527: 47.7  $\mu\text{m}$

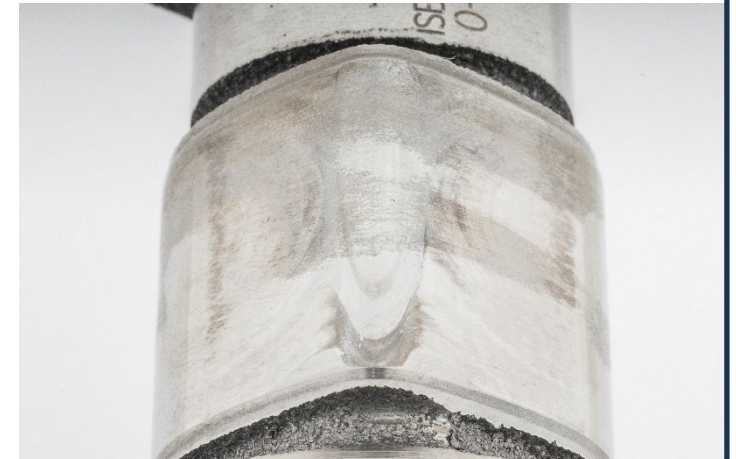
CMIR-202553 EOT: 57.3  $\mu\text{m}$

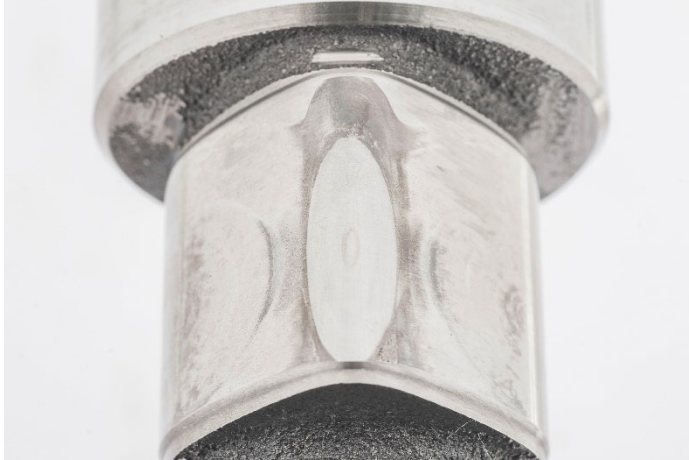
CMIR-196523: 33.3  $\mu\text{m}$

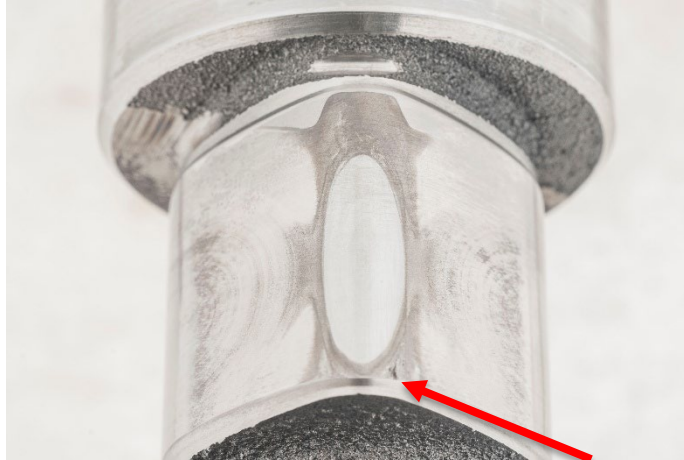
CMIR-196522: 39.3  $\mu\text{m}$

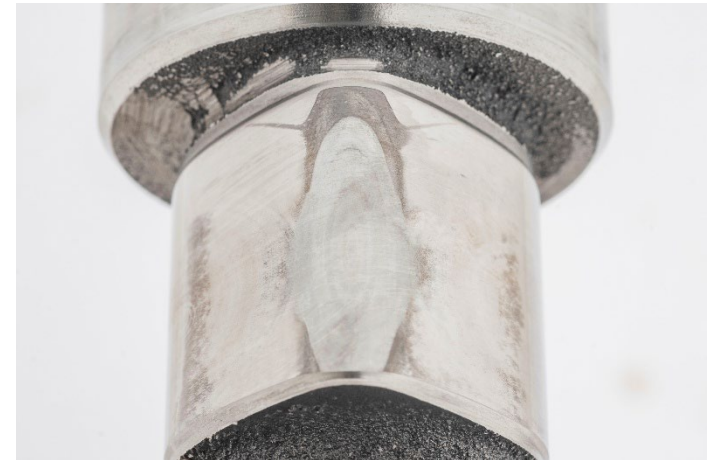
CMIR-195526: 51.7  $\mu\text{m}$

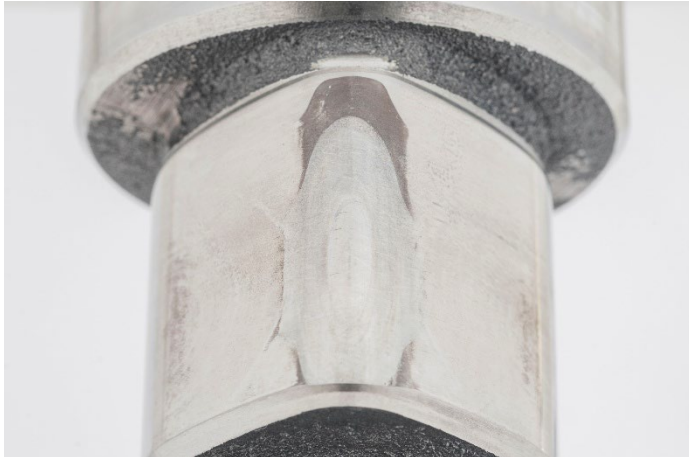
CMIR-195527: 43.3  $\mu\text{m}$

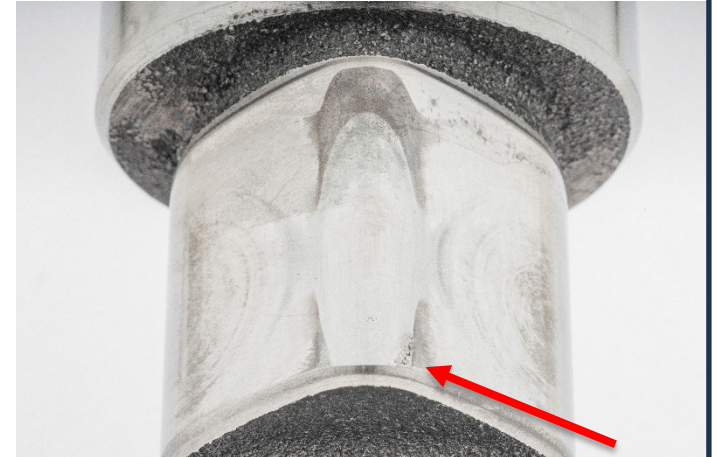
CMIR-202553 EOT: 34.7  $\mu\text{m}$

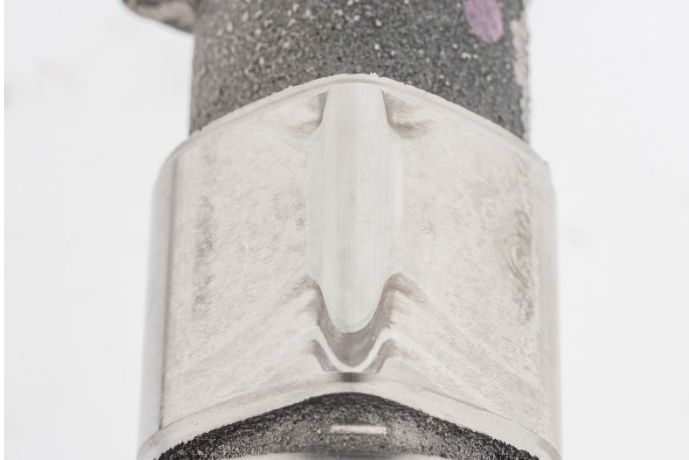
CMIR-196523: 37.0  $\mu\text{m}$

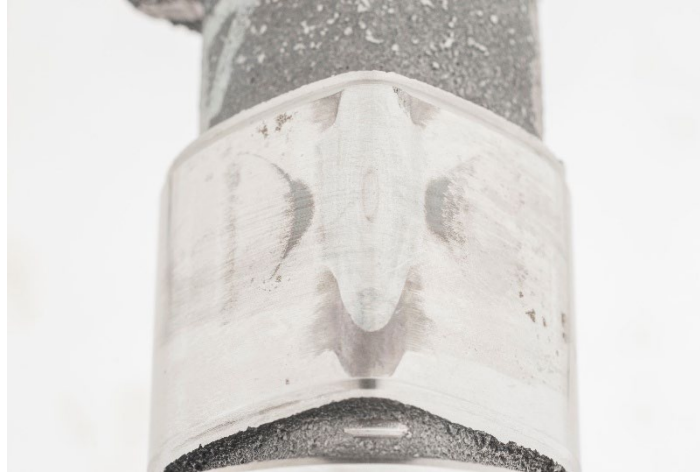
CMIR-196522: 44.7  $\mu\text{m}$

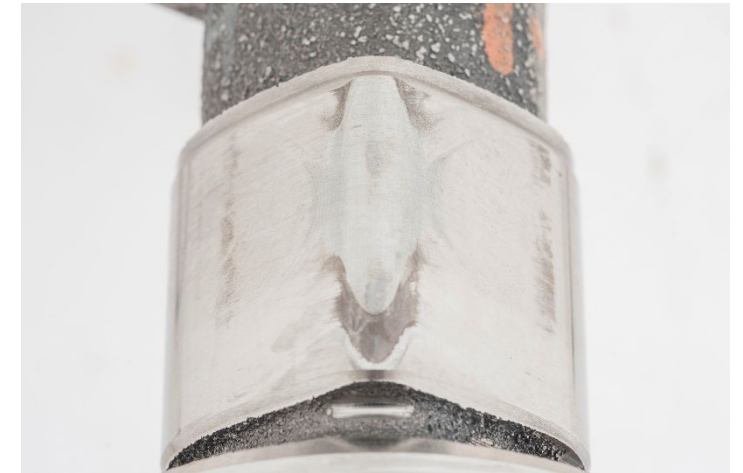
CMIR-195526: 39.3  $\mu\text{m}$

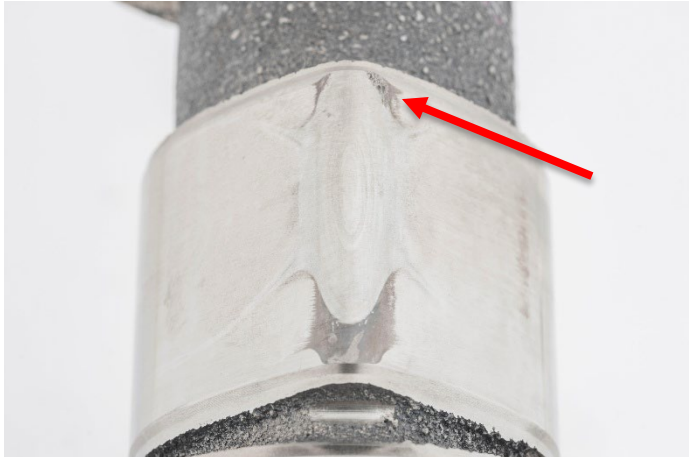
CMIR-195527: 47.3  $\mu\text{m}$

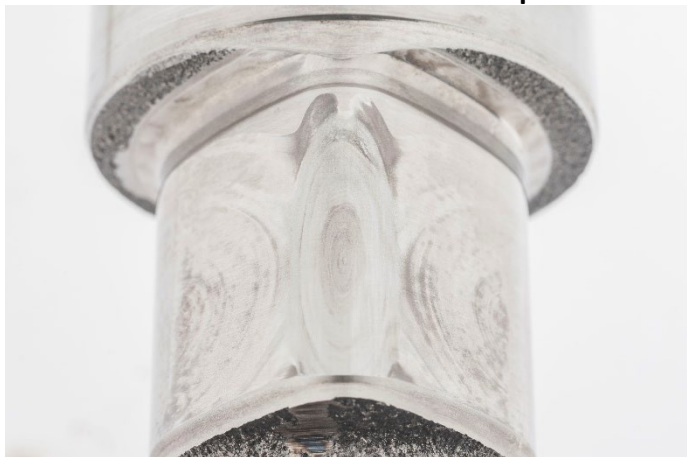
CMIR-196523: 37.0  $\mu\text{m}$

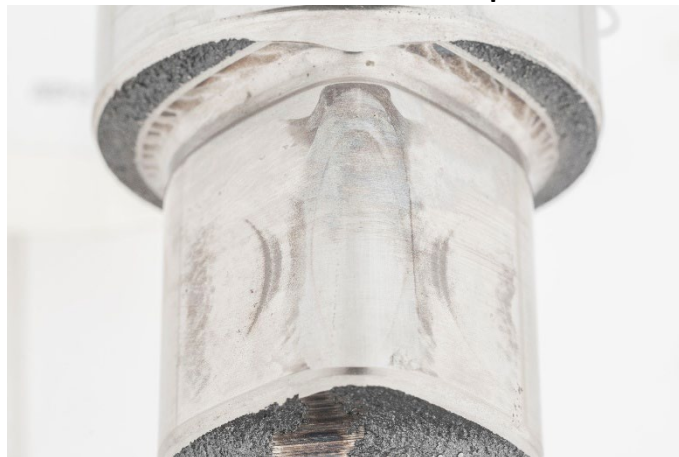
CMIR-196522: 43.3  $\mu\text{m}$

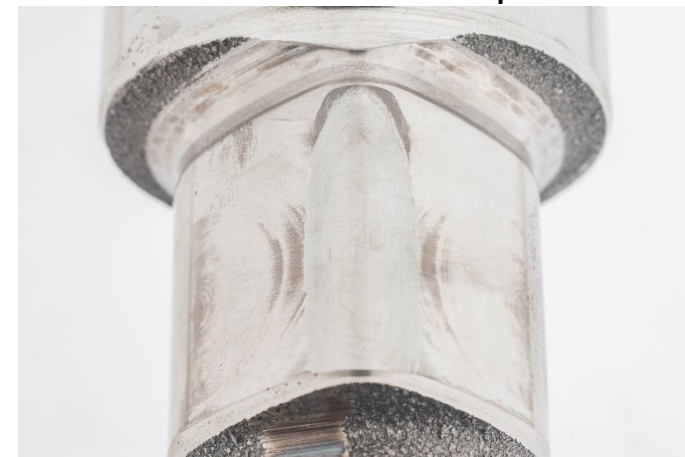
CMIR-195526: 60.3  $\mu\text{m}$

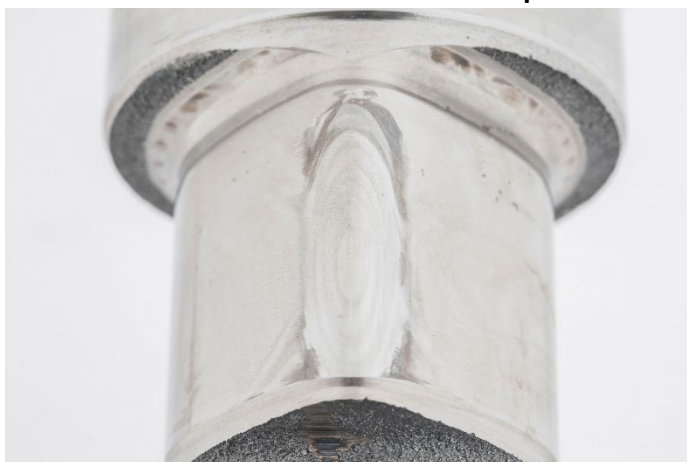
CMIR-195527: 20.7  $\mu\text{m}$
